RECENT ADVANCEMENTS UNCOVER A PREVIOUSLY UNIDENTIFIED CAUSE OF EARLY PEX FAILURE

How the mechanical stress of bent crosslinked polyethylene results in accelerated stress-corrosion cracking of minimally oxidized plumbing piping

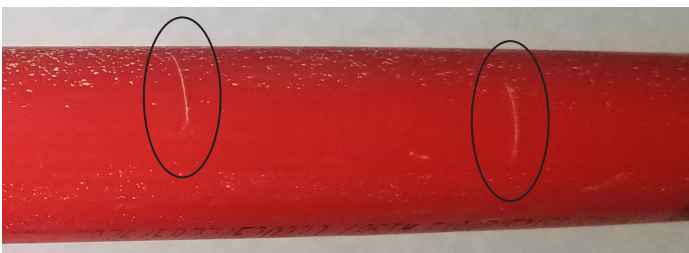
FIGURE 1. PEX failure resulting from a combination of mechanical stress from bending and chlorine induced degradation*

While these stage 3 failures are explainable exceptions to the extrapolated time-to-failure based on the documented limitations of ASTM F2023, the circumferential cracking shown in figure 1 is an example of a “stage 2” or brittle failure that cannot be explained by the previously mentioned factors.

In the example shown in figure 1, a ¾” section of PEX-b tubing experienced multiple circumferential through-wall cracks on the hot water side after approximately 10-12 years in service in a home in California.

Analysis of the failure found a degraded layer between 50-100 microns thick, which is less than one tenth of 1% of the thickness of the ¾” PEX pipe. Based on this depth of degradation after 10-12 years, it is reasonable to extrapolate that the pipe should have remained in service without experiencing a stage 3 failure for many years, likely exceeding the 50-year expectation. So why did the pipe fail?

Forensic analysis of the failure suggests that the through-wall crack is the result of stress-corrosion cracking which began in the thin embrittled layer that had been degraded by the chlorinated water, and then propagated via slow crack growth

under mechanical stress caused by flexing of the pipe. This is understood to be the reason the cracks developed circumferentially rather than longitudinally.

Yet, because the cracking originated on the interior wall of the pipe on the outer radius of a curve, the mechanical stress in the original crack location should have been in compression, which would be an unlikely location for a crack to form. What mechanism could have created stretching forces where the pipe should have been under compression?

Because of this, it is advisable that plumbing contractors should avoid “flexing their PEX” – meaning both bending pipe that was crosslinked while straight or straightening pipe that was crosslinked in a coil. In either case, the act of bending the PEX pipe may put the system at risk of accelerated failure.

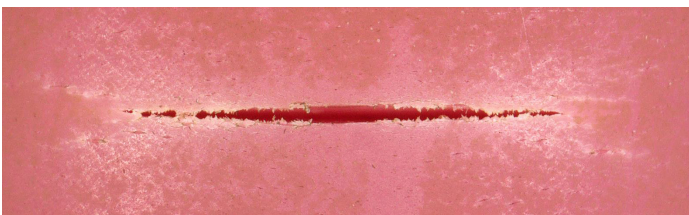
FIGURE 2. Through-wall crack, from interior (magnified)

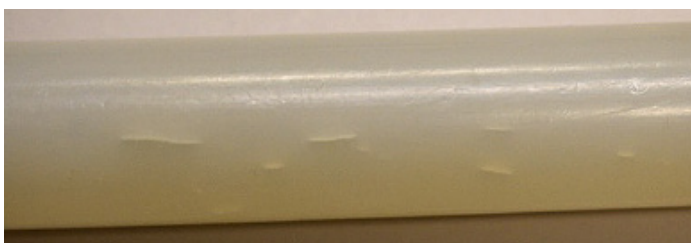
Each of these conditions can significantly accelerate the rate of oxidative degradation, resulting in what ASTM F2023 calls a “stage 3 failure” or a pure oxidative failure characterized by multiple through-wall cracks.

FIGURE 5. Stage 3 PEX failure from a system reported to experience intermittent water pressure spikes above 80psig in chlorinated water

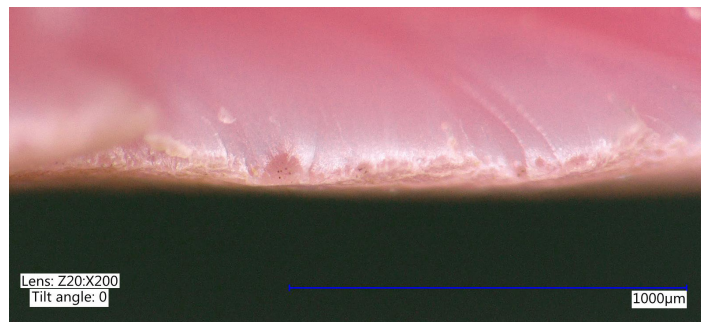
FIGURE 6. Degraded layer of PEX piping approximately 50-100 microns thick after 10-12 years in service

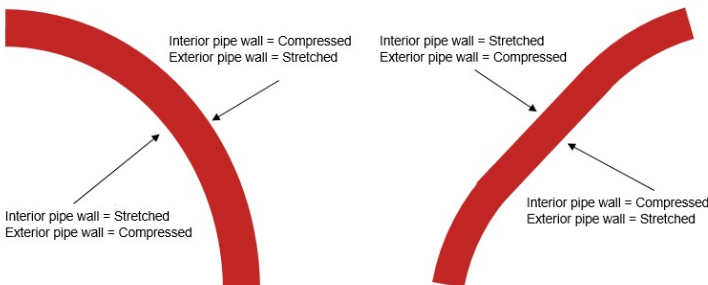
FIGURE 7. Mechanical stress from bending a straight pipe (PEX-a & PEX-c)

FIGURE 8. Mechanical stress from straightening a bent pipe (PEX-b)

When any piping, including PEX piping, is bent into a configuration other than its locked-in natural state, it places the pipe under mechanical stress. As shown in figures 7 and 8, if the pipe's natural state is coiled, then straightening the pipe or bending it in the opposite direction of its initial coil will induce stress; if the pipe's natural state is straight, then bending it will induce stress.

When the interior pipe wall is stretched, it creates a vulnerable point where a thin oxidized layer can crack and then propagate through the wall to create a pinhole leak.

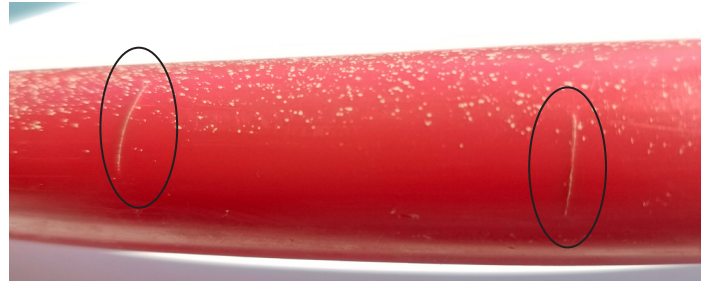
FIGURE 9. Exterior view of circumferential cracking resulting from a combination of mechanical stress from bending and chlorine-induced degradation

As shown in figure 9, the exterior surface of the crack visually appears to be the result of external damage. Indeed, this failure and other similar failures have reportedly been visually diagnosed as the result of a number of external physical sources ranging from vibration or rubbing of the pipe against a structural member to pipe that was nicked with a cutting tool or other blade during or after installation. Without a more thorough, scientific evaluation of the failures it would be nearly impossible for a plumbing contractor or homeowner to tell the difference between physical damage and this form of chlorine-induced stage 2 failure.
