Periodic Condition Report

Inspected on June 22, 2020 9:37 AM

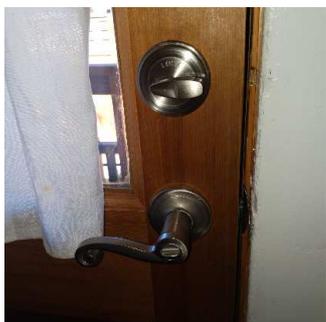
Other Issues
06/22/2020 10:41 AM

Items	Values	Notes
Water Damage	Status: All good	
Window / Blinds / Screens	Status: All good	
CO / Smoke Detector Battery Check	Condition: Not present	
Other Issues	Status: Noticeable issue(s)	tenon says bottom lock not working properly
General Cleanliness	Condition: Clean

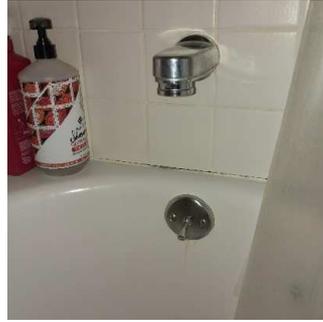
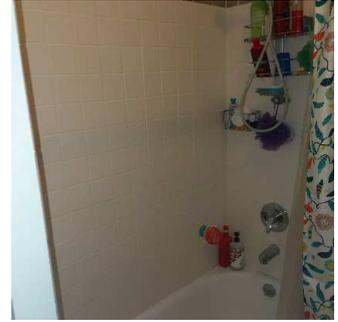
Items	Values	Notes
Toilet	Status: All good	all good
Faucet & Sink	Status: All good	all good
Under the sink	Status: All good	all good
Tub / Shower	Status: All good	all good
Tiles / Grout	Status: Noticeable issue(s)	tile good, minor loss of caulk under spout area
Ventilation Source (Fan)	Status: All good	
Window / Blinds / Screens	Status: All good	no windows or blinds in this room
Other Issues	Status: All good	
General Cleanliness	Condition: Clean

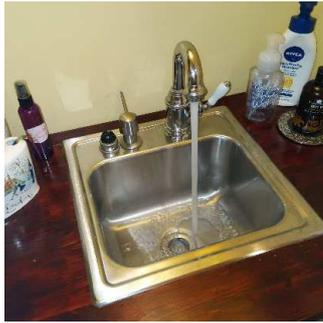
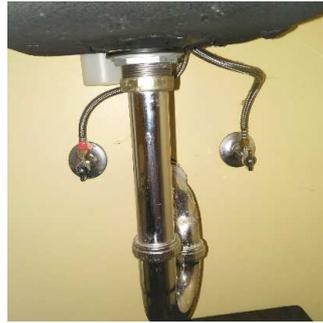
Items	Values	Notes
Toilet	Status: All good	no leaks
Faucet & Sink	Status: All good	sink drains but slow - I think it's due to the zoom drain setup and normal for this type of configuration
Under the sink	Status: All good	
Tub / Shower	Status: All good	
Tiles / Grout	Status: All good	no tile , seals in tact
Ventilation Source (Fan)	Status: All good	fan is a little noisy but works well
Window / Blinds / Screens	Status: All good	
Other Issues	Status: All good	
General Cleanliness	Condition: Clean

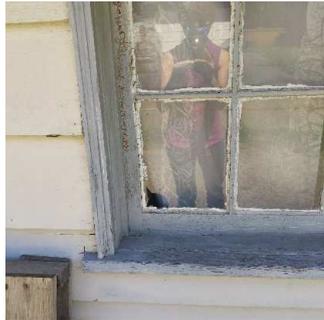
Window / Blinds / Screens
06/22/2020 10:59 AM

Items	Values	Notes
Garage Door	Status: All good	
Water Damage	Status: All good	
Window / Blinds / Screens	Status: Noticeable issue(s)	window broken
Furnace Filter	Condition: Dirty	it appears furnace has not been serviced in some time The filter also looks older and should probably be replaced
Other Issues	Status: All good	
General Cleanliness	Condition: Clean

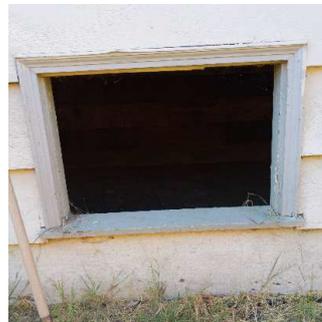
Building Exterior
06/22/2020 10:16 AM

Items	Values	Notes
Building Exterior	Status: Noticeable issue(s)	crawl space access should be covered
Roof / Gutters / Downspout	Status: Noticeable issue(s)	branches over hanging backside of roof with some debris and gutters not too bad but probably should keep an eye on it
Hose Spigot	Status: All good	
Landscaping	Status: All good	
Tree Branches - nothing too close or hanging over the property	Status: Noticeable issue(s)	looks okay now but getting close to needing another trim again perhaps in the fall
