Magellan Roof Inspection Report

Customer Name	Mr. & Mrs. John Smith
Customer Address	123 Historic Home Lane St. Louis, MO 63131
Customer Phone Number	(555) 555-5555
Customer Email Address	
Historic Roofing/Building Specialist Completing Assessment	Tony Raleigh
Date of Assessment	2021-03-01
Temperature	54
Weather	Clear

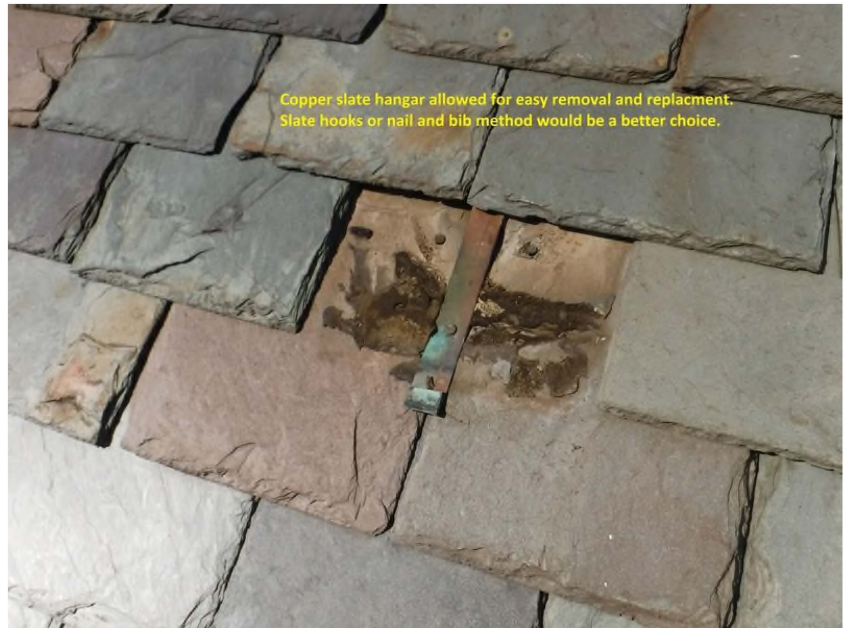
Here we can see the copper hanger that was installed to hold the replacement slate in place. While these hangers are not the best method for replacing damaged slates, it does allow for easy removal to view the fasteners.

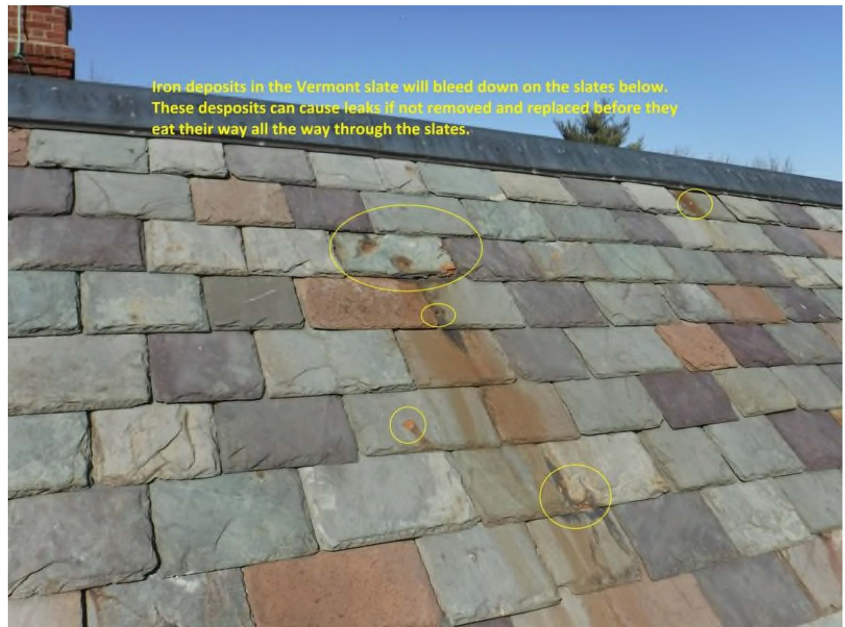
The roofing slate appears to be mostly original to the home. Some replacement slates are obvious around the system. The slates with noticeable iron deposits should be replaced. The rust stains left from the knots, knurls and inclusions are impossible to remove. However, this is the nature of Vermont slate. (Long lasting roofing slate)

One or two of these iron deposits can cause a lot of staining.

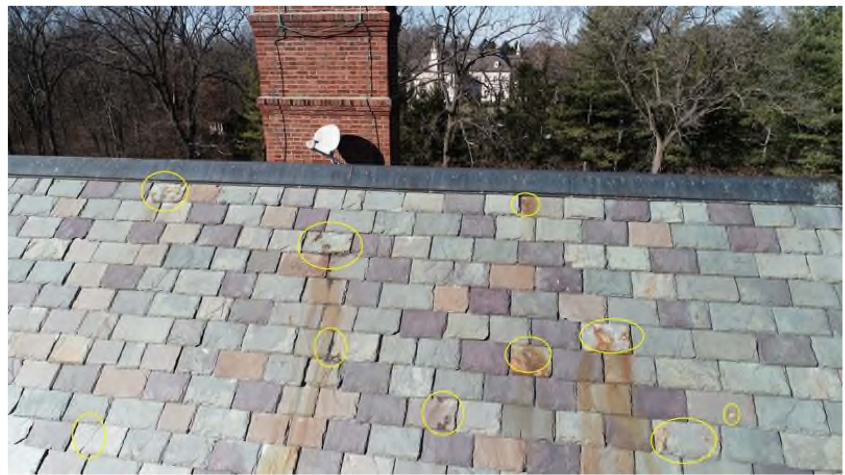
Often, these knots and knurls do not open up as iron deposits.

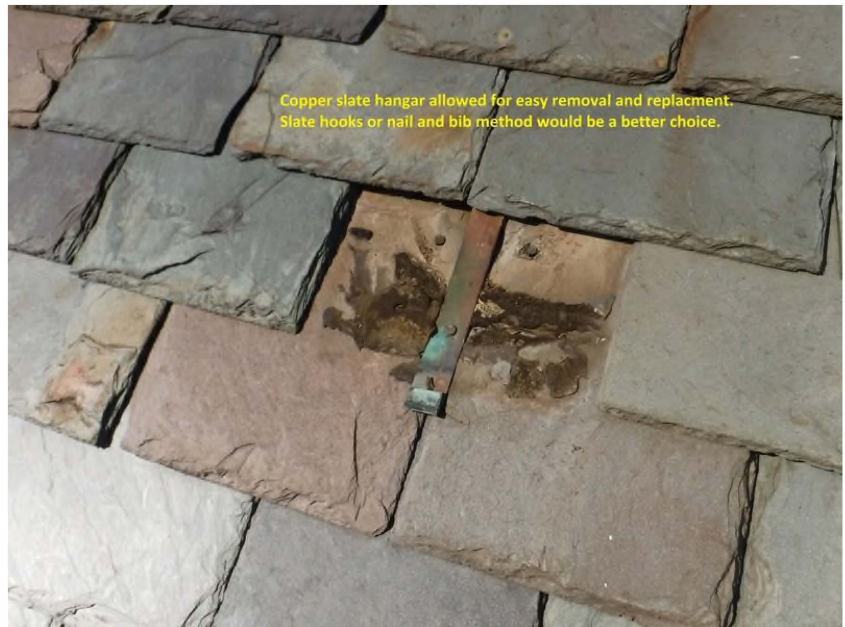
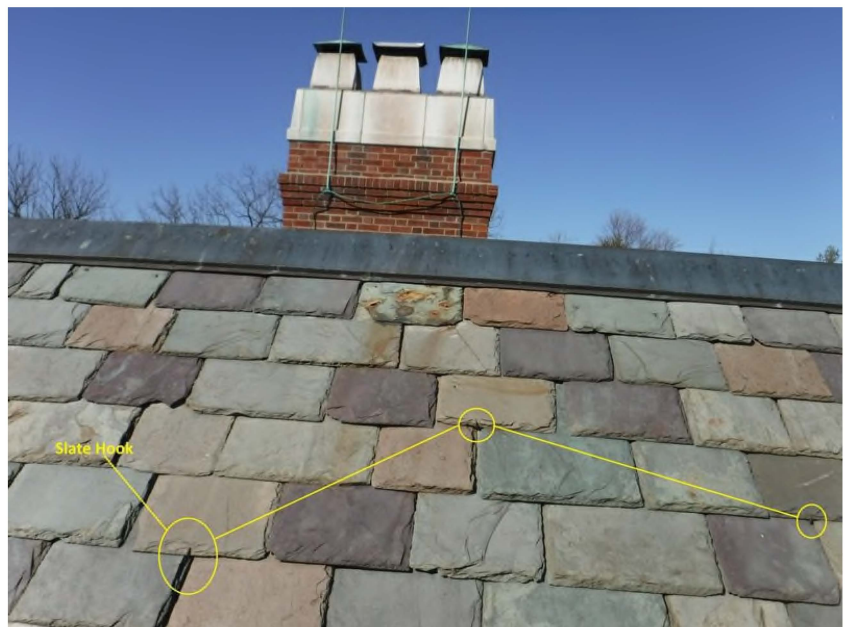
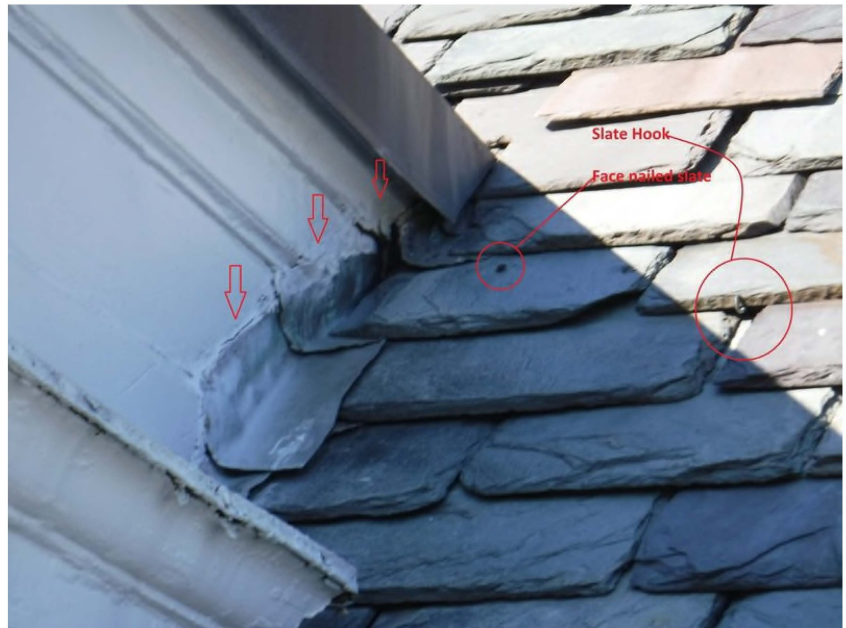
Fasteners/Battens/Straps Photos

Fasteners/Battens/Straps Comments There are some slate hooks, custom fab slate hangers, and some bibbed slates. Very few face nailed slates were noted.

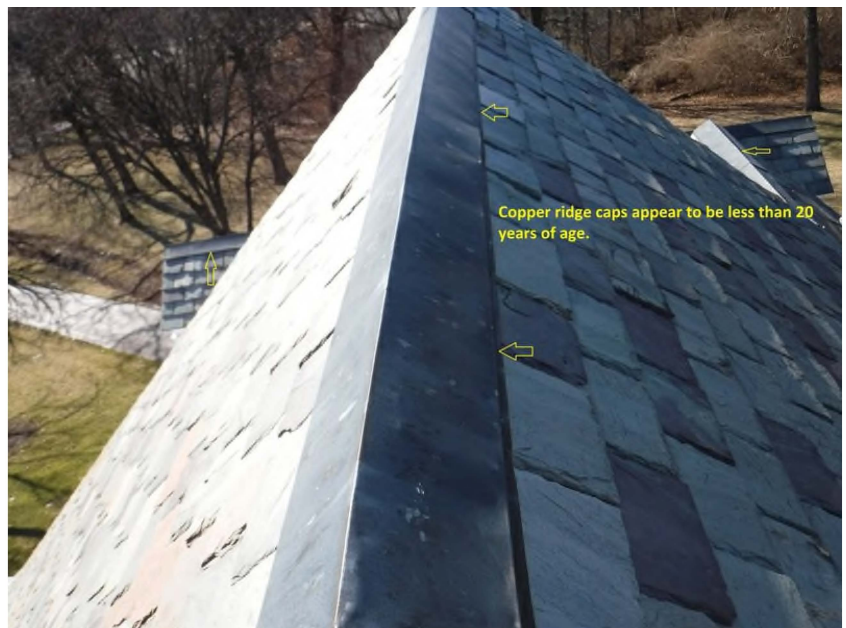
Hips & Ridges Photos

20 oz. copper ridge caps were installed within the last 15-20 years. Hard to beat this detail for longevity and for preventing microbial build-up on the slates.

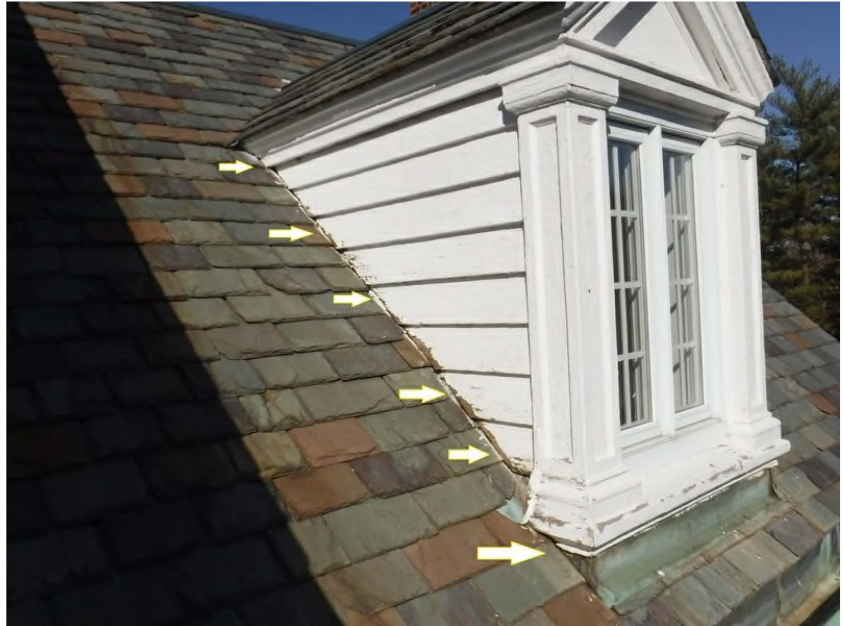
Most of the wall to roof flashings installed on the slate roof are directly under the wooden siding. Wall flashings along the low sloped roof are original.

Copper flashings installed at each course of slate turn up and go behind the siding.

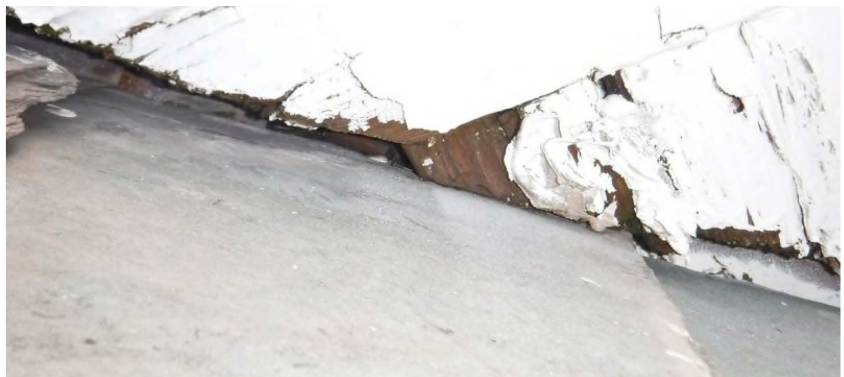
Where the dormer siding meets the slate roof.
it would be nice to see a j-channel installed to separate the wooden siding from the water flow along the slate roof.

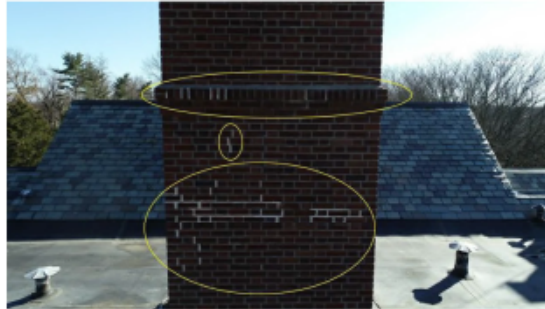
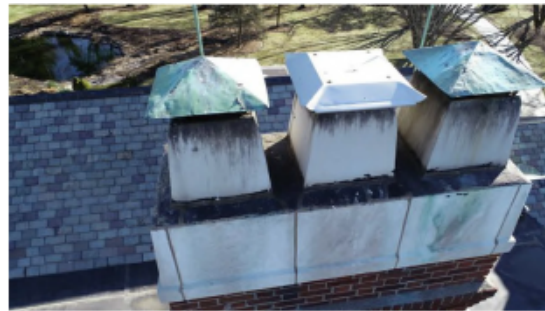
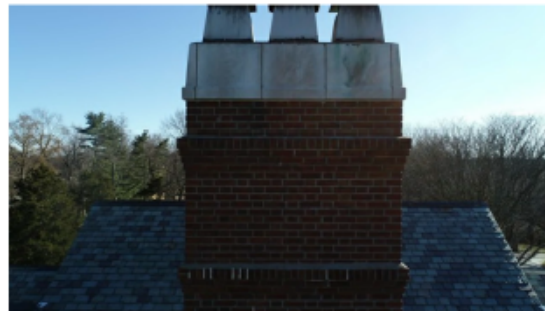
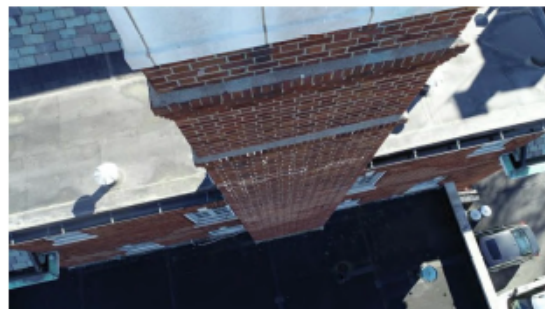
Chimney Cladding/Masonry Photos

Acceptable

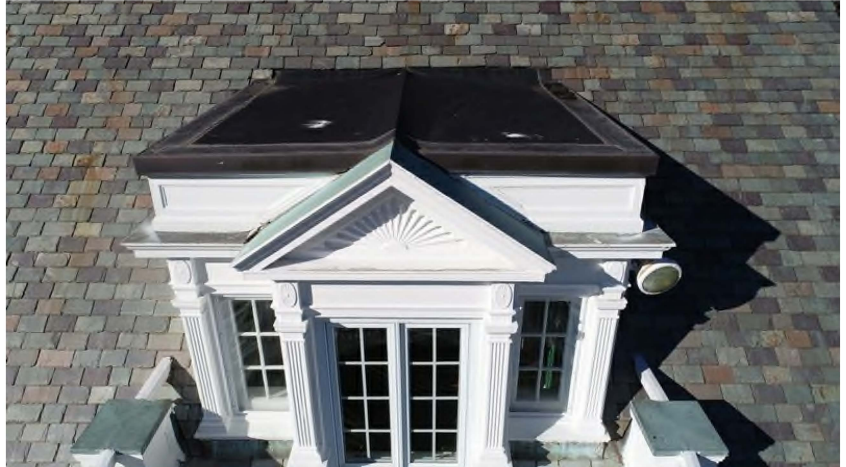
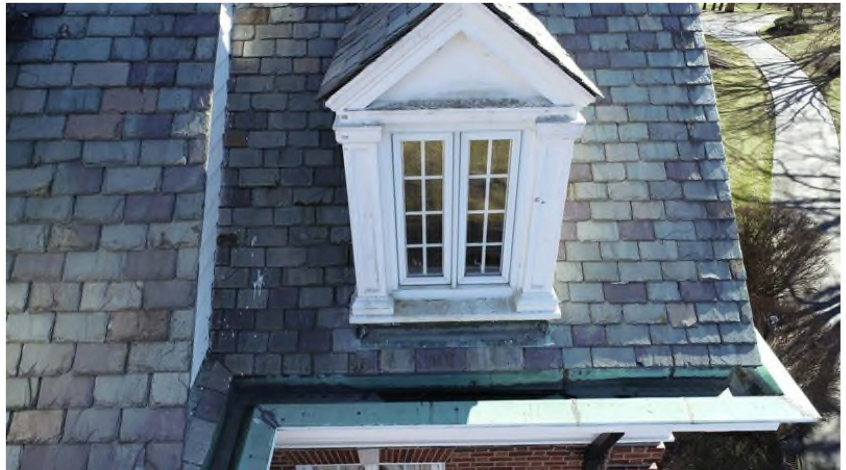
Exterior Woodwork Photos

The exterior woodwork is in good condition. Previous homeowners have done a good job of keeping the home painted.

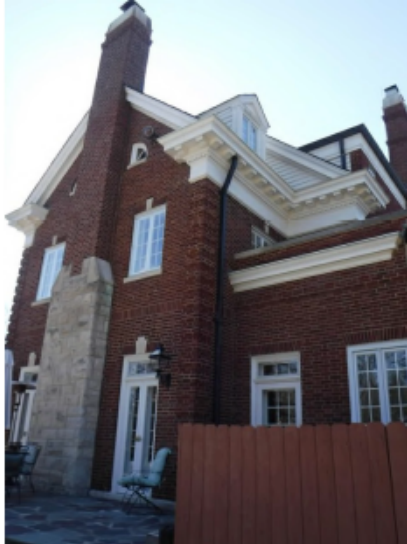
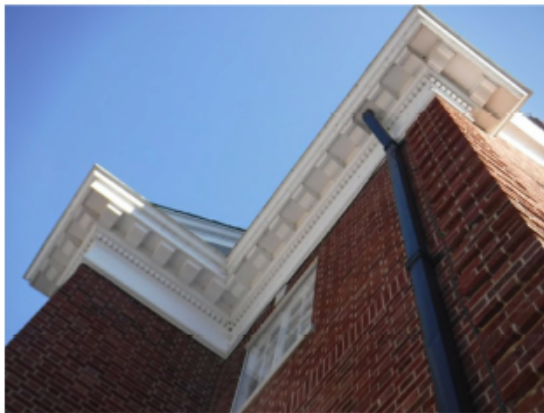
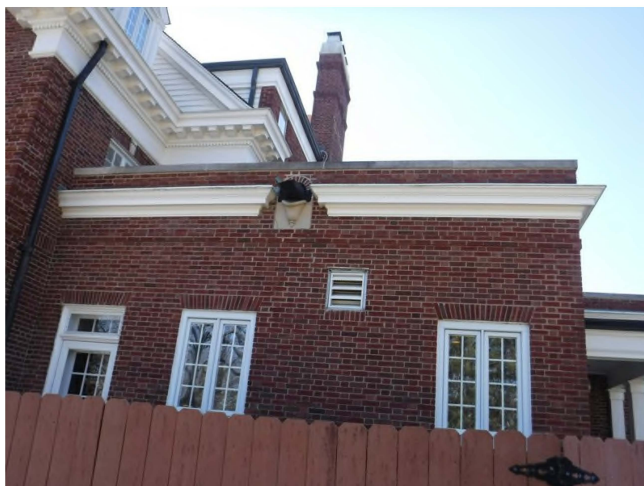
Fascia & Soffits Photos

Looks good!

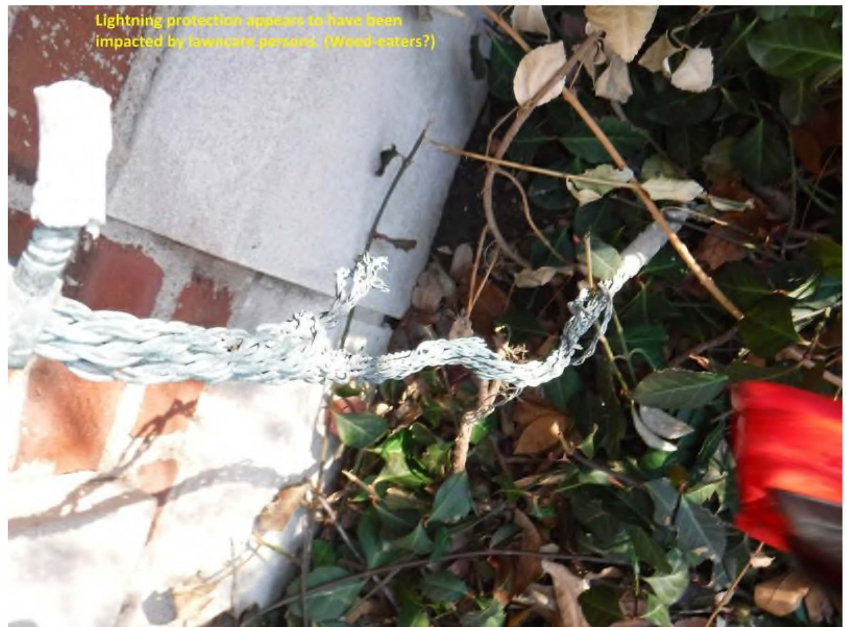
Lightning protection appears to have been damaged

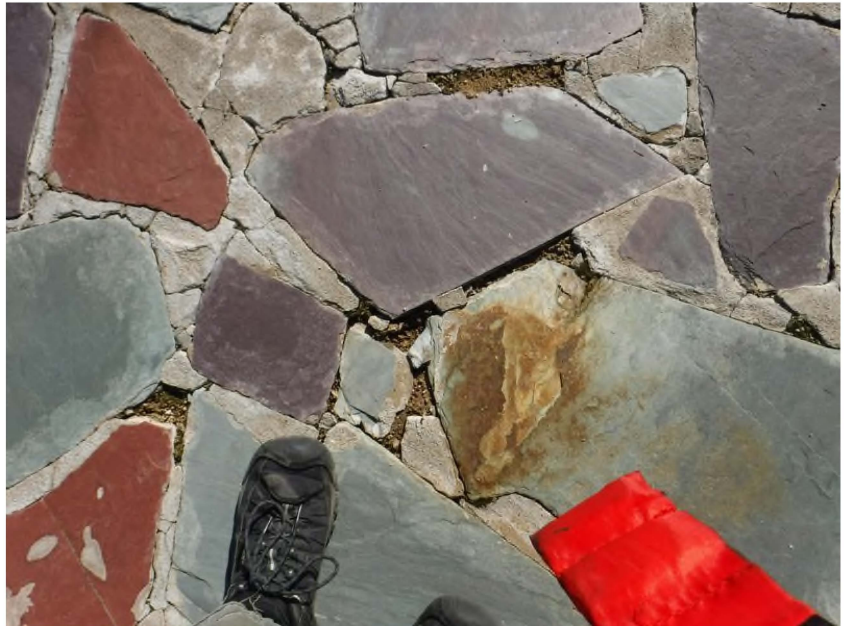
Vermont slate was a brilliant choice for the pavers. A mason will need to visit and determine next steps for these areas.

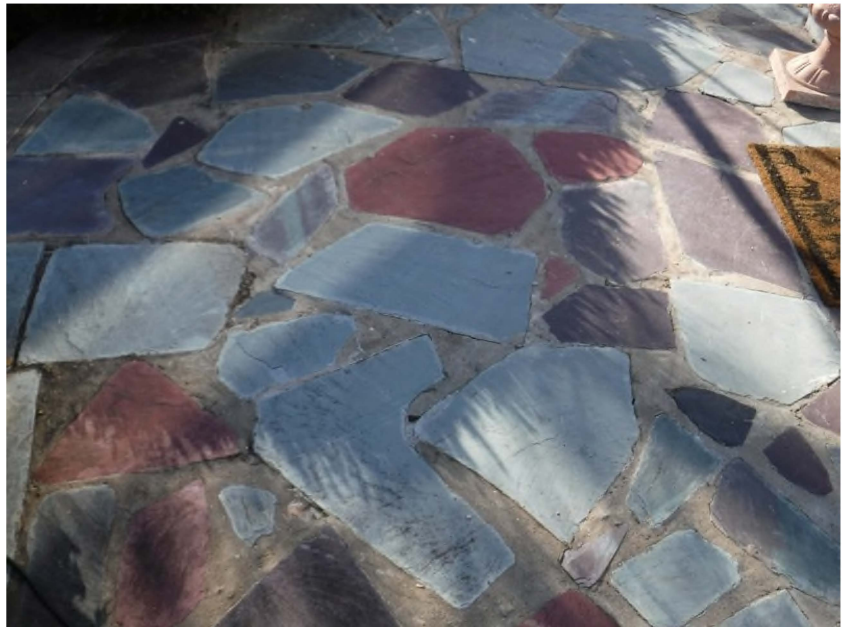
Here, we have, Vermont multi-colored slate and New York Red Slate! Really cool! This slate is about 3-4 inches thick!

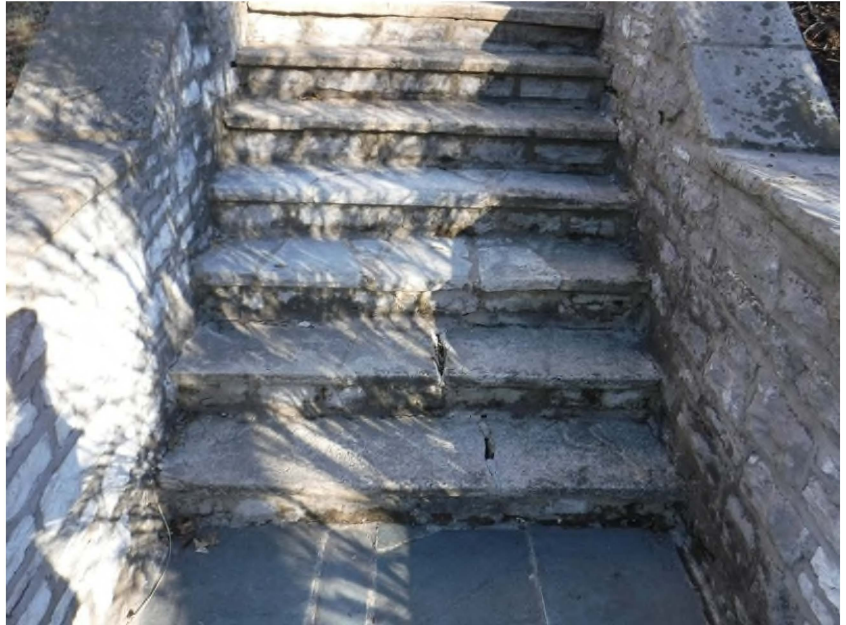
There opportunities for additional investments in the masonry around the front elevations.
