### COMMON PROBLEMS:

## VW17, VW18, VW20, VW21

### VOLKSWAGEN

TLT-VW17/18/20/21-001

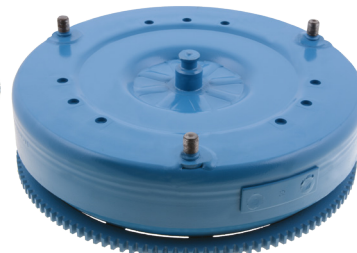
**FIG 1.**

This stud has threads the full length of the stud.
