Background Information

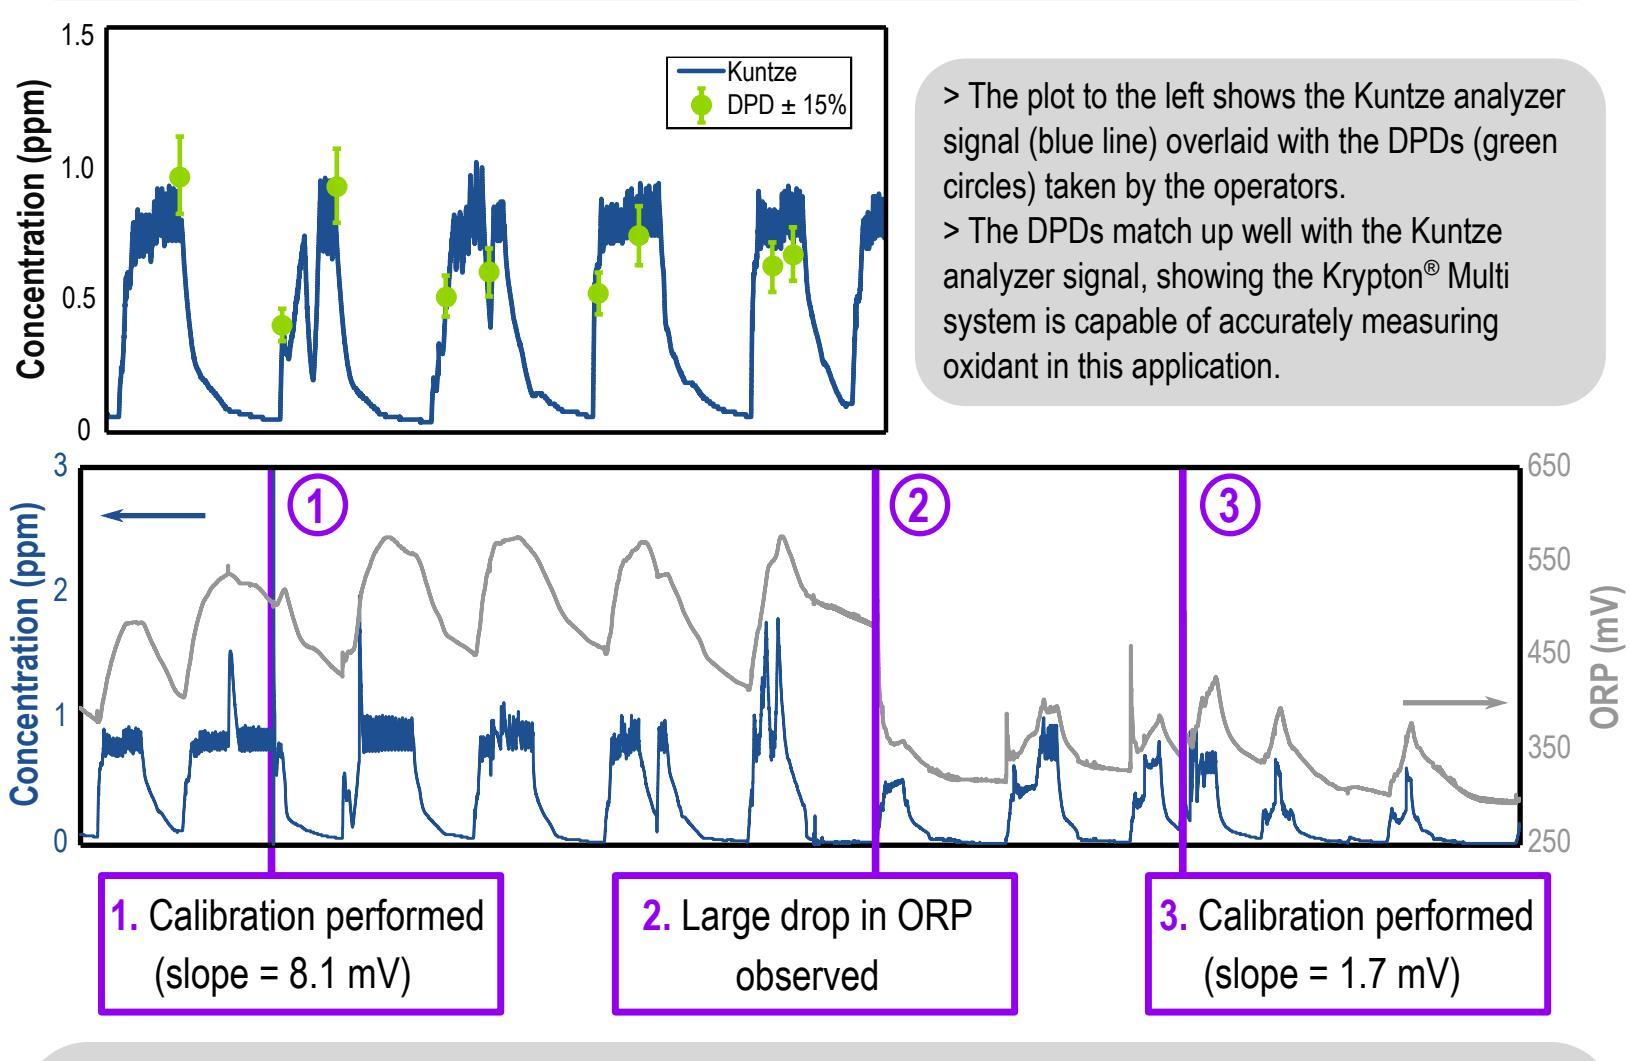
> The above plot shows the cooling tower's oxidant concentration (blue line) and the ORP measurement (grey line).

1. This calibration slope of 8.1 mV provided the "baseline" for how the sensor responded in the cooling tower.

- 2. This was the point where the operators had difficulties maintaining their oxidant residual. There was also a large drop in the ORP measurement at this time, which indicated that something in the tower's chemistry had changed.
- 3. The calibration performed at this point had a much lower slope (1.7 mV) compared to the calibration at point 1.
- > By interpreting the differences in the calibration slopes and the large drop in ORP, the Kuntze support team advised the tower operators to look for any external anomalies which could have changed the tower's chemistry.
- > Further investigation showed that the corrosion inhibitor sensor had failed, resulting in a massive inhibitor overdose.
 - >> The corrosion inhibitor consumed the available oxidant, which is why the concentration was lower than expected
