Aluminum Wiring

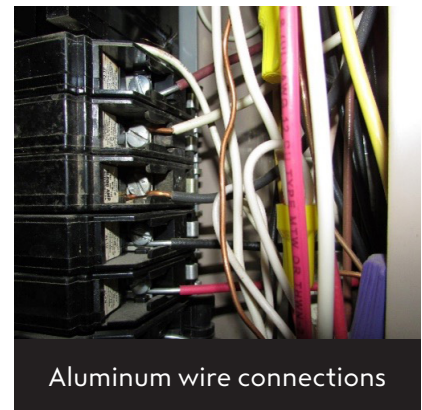
Aluminum wire connections

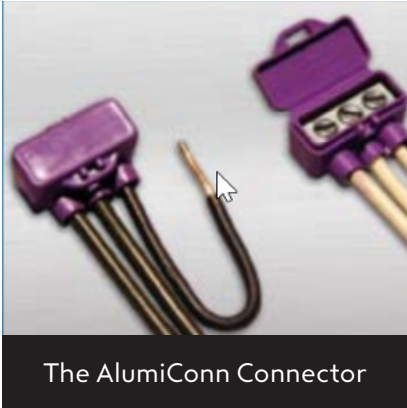
The AlumiConn Connector

1. Rewire the building with copper wiring. This is the most effective long-term repair. This should be considered the best practice solution and is West Bend's preferred method of repair.
2. The second method involves the splicing of aluminum wire to copper wire with one of two specialty-designed connectors. They are Copalum crimp connections or Alumicon connectors. The repaired terminals should be marked with CO/ALR, which stands for Copper/Aluminum revised.
