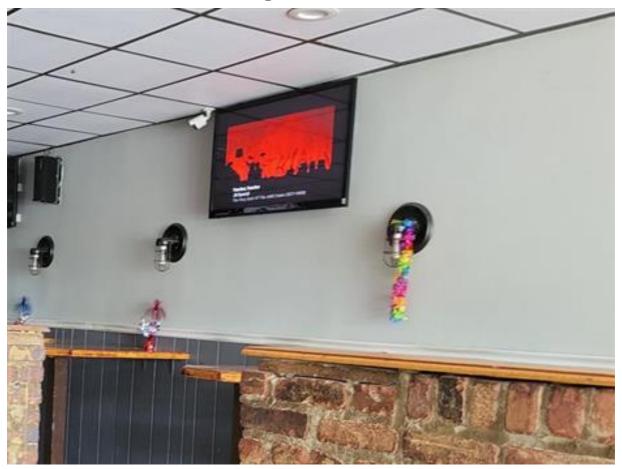
Missing CO Detector

The damaged/missing smoke or carbon monoxide detector should be repaired or replaced to improve fire safety and reduce the loss of life risk.

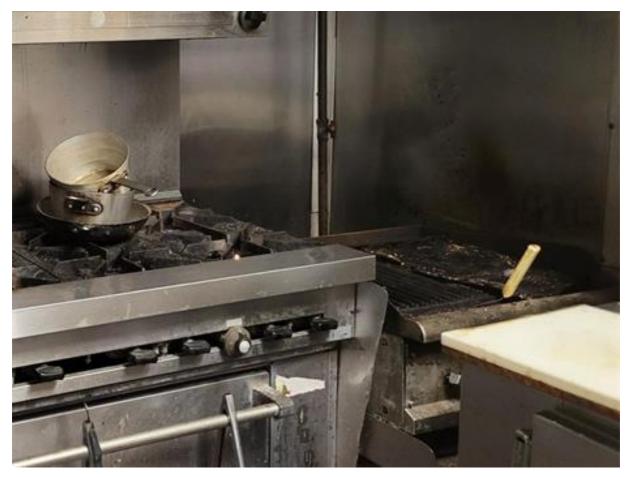
grease/debris build up

Cooking equipment was noted to have excessive grease or debris build up which presents a fire hazard. The equipment should be cleaned to reduce the hazard.

The range and hood had excessive build up of grease. The owner stated they already have contracted a company to do a deep cleaning of the entire area.

Does any cooking equipment have excessive grease/debris build up? Yes

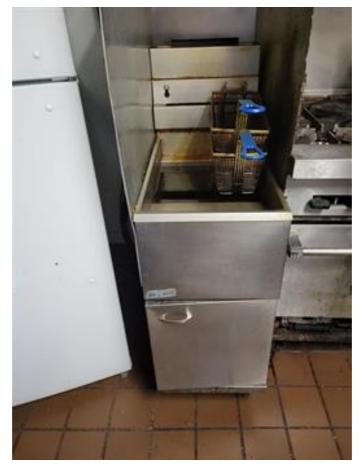
Fryers

Deep Fat fryers are a minimum of 16 inches from open or unprotected flame? No

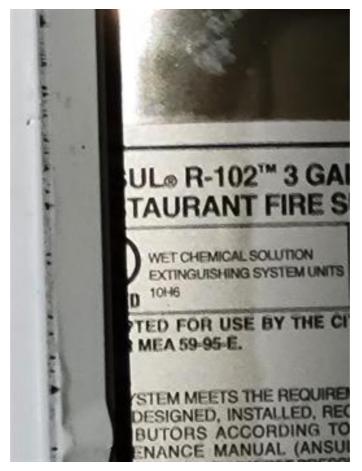
UL300 Label

UL 300 compliance label was seen on system
