OSMO-C-TRUSS®

OF RELIABLE RESTORATION

This paper shows a brief history of the C-Truss steel restoration method and includes data on the re-inspection of over 117,000 restored poles that validates successful life extension of over 40 years. Life extension of a utility asset qualifies for capital treatment and details of capital budget optimization are also explained in this document.

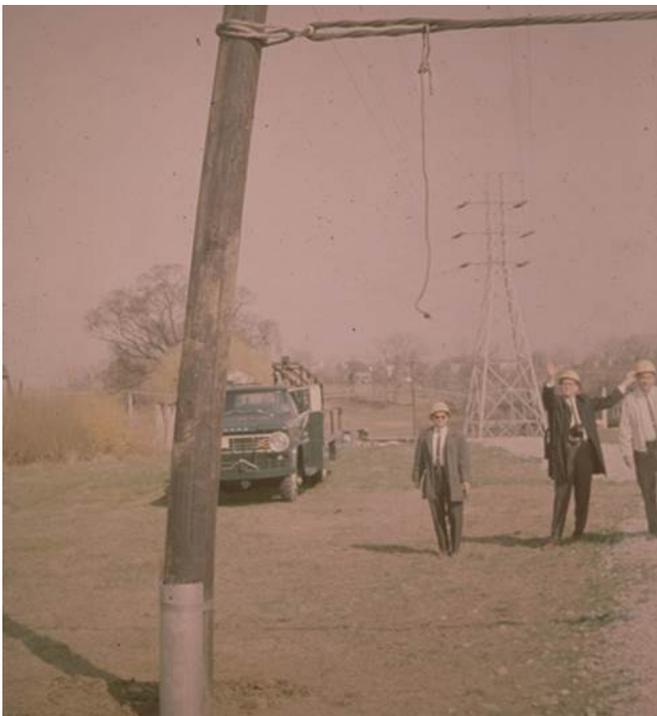
Figure 1 1966 In-situ Load Testing of C-Truss

In the 1960’s, utility companies often conducted their own tests of new products that were brought to market. **Figure 1** is an example of full-scale testing of the early C-Truss system conducted at a Midwestern utility company in 1966.

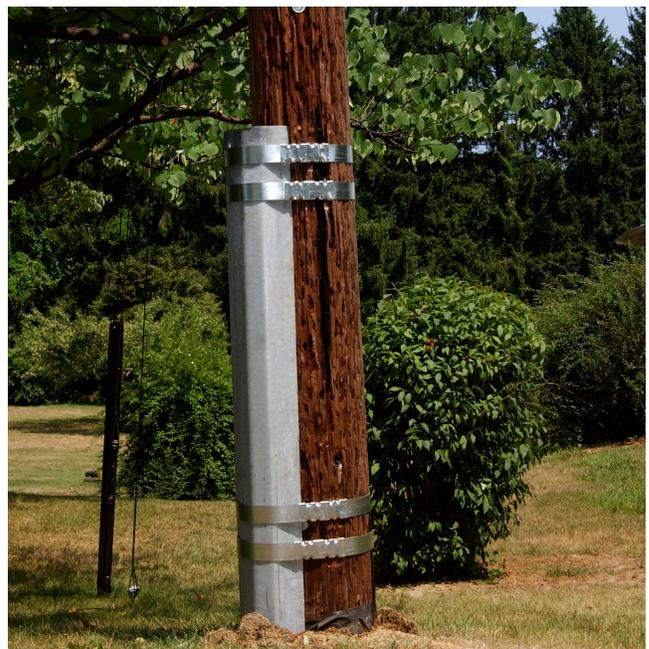
Optimized C-Truss Installed

In the mid 1980’s, the C-Truss had its first major design overhaul. The general C-shape was improved by creating truss sizes that efficiently coincided with NESC code requirements. Higher strength steel (80,000 psi) was incorporated to achieve greater bending strength in lighter weight trusses, further optimizing the design.

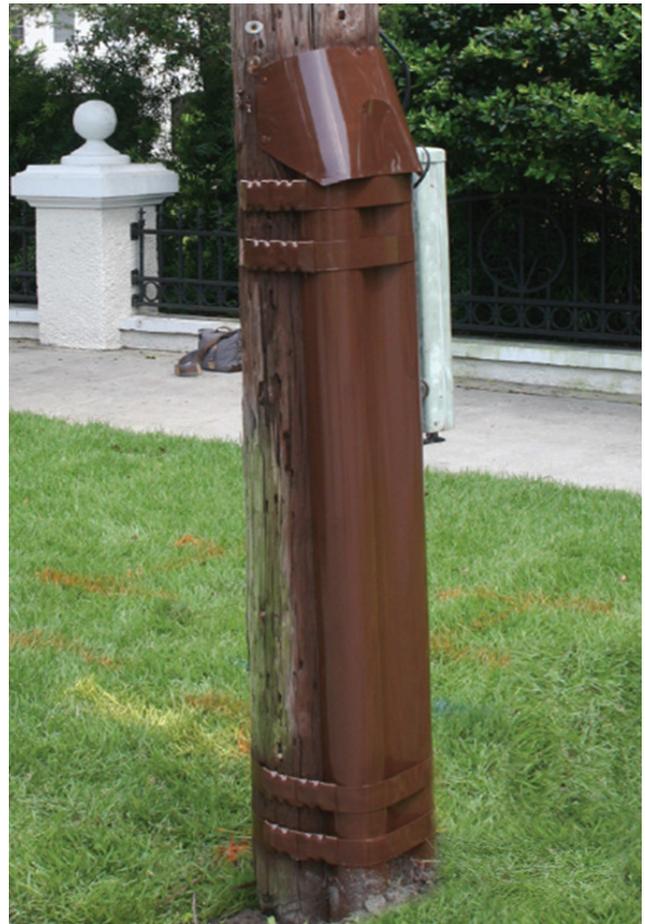
Patented C2-Truss Installed

The patent-protected C2-Truss™ provides a lighter, stronger, and lower cost solution for restoration, giving an even greater incentive for the pole owner to restore rather than replace their rejected wood poles.
