Osmose

Implementing a practical and cost-effective life extension solution in a protected wetland

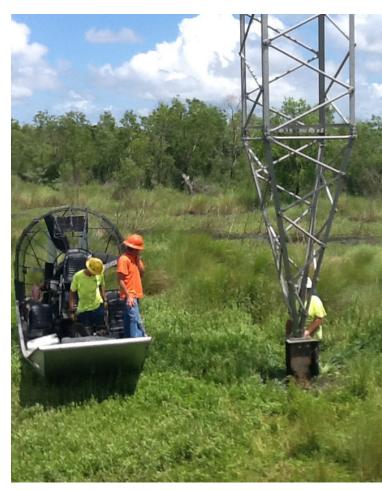
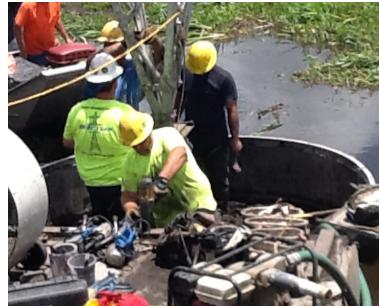
A routine aerial inspection revealed corrosion on the tower foundations. The aerial inspection was followed by a detailed marine survey, which revealed the severity of corrosion and quickly became the utility's top priority. The structures were only accessible by boat in the protected wetland, so the Osmose structural engineering team designed steel H-pile foundation reinforcements and a construction methodology that would limit the construction footprint, reduce environmental impact, and safely restore the towers to code-mandated strength.

The detailed assessments required the de-watering and excavation of each tower foundation so the Osmose structural engineering team could develop a practical and cost-effective solution. The foundations were de-watered and excavated 18-24 inches below the mudline, which revealed the greatest amount of deterioration, spanning from the splash zone to the mudline. Following the excavation, the extent of corrosion was assessed so that the Osmose engineering team could recommend and prioritize restorations.

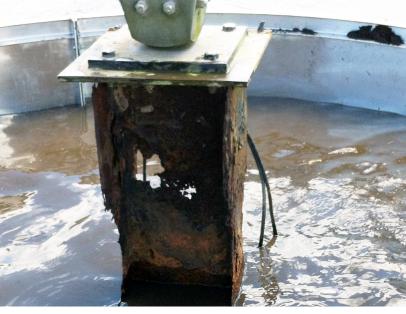
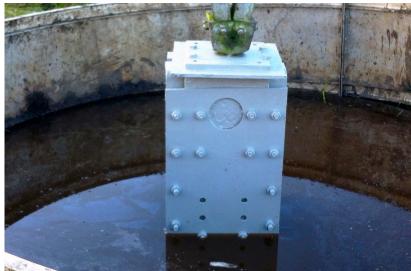
The restorations were grouped into two phases. The first phase included high-priority structures that required a crane to support the structures for an added safety factor. The line was re-energized, and the tower foundations were restored. The second phase included structures with less critical section loss that did not require a crane or outage.

For both phases of this restoration, the foundations were cleaned and cost-effective engineered repair solutions were installed. All of the foundations then received a protective coating, and cathodic protection was installed to mitigate the on-set of further corrosion.
