Anti Ligature Air Conditioning Guards

## Mental Health Hospital In The South Of England

### CASE STUDY

**SUMMARY:** The installation of Anti Ligature Air Conditioning Guards and Surface Mounted - Clinched Studs

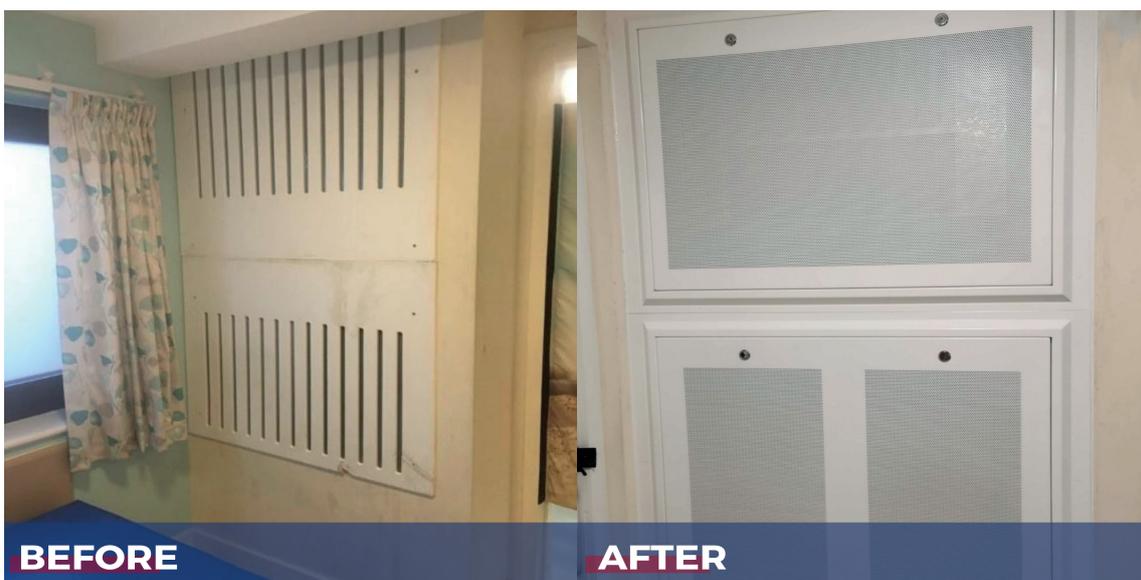
BEFORE

AFTER

Previous air conditioning guards were a hazard, as children were kicking the bottom panels of the guard causing them to break.

Taking this into account, children ended up snapping the panels to self-harm or attack the staff - posing a health and safety risk to those at this hospital.

The maintenance staff at the hospital had to resort to adding extra sections of wood to make the covers stronger and more durable, only for the children to find a new way to cause damage and disruption.

The air conditioning guards delivered were clean looking with no visible fittings on display and easy access for cleaning. The strength was also considered with the guards being made from 2mm steel with a strengthening strut inside. Finally, the guards were made to be anti-ligature with IP3x grilles and 45-degree chamfered edges.
