WHITE PAPER / **DC INTERFERENCE**

# CONTAINING THE COSTS OF STRAY CURRENT

BY Tyler Laughorn

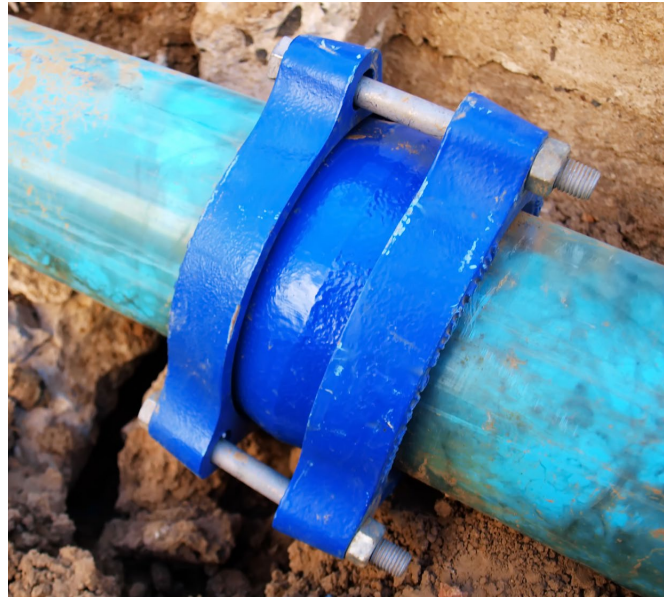
In an impressed current CP system, current is intended to flow from a current source (such as a rectifier) to an anode, through the soil to the metal asset, and then back to the current source. However, that current may take a stray path while in the soil, and some of it may jump onto an unintended asset, then jump off of that asset at a different location, before continuing on to the correct asset to complete the circuit. At the location where the current jumps off the unintended asset, stray current corrosion will occur, shortening the life span of that asset (See Figure 2).

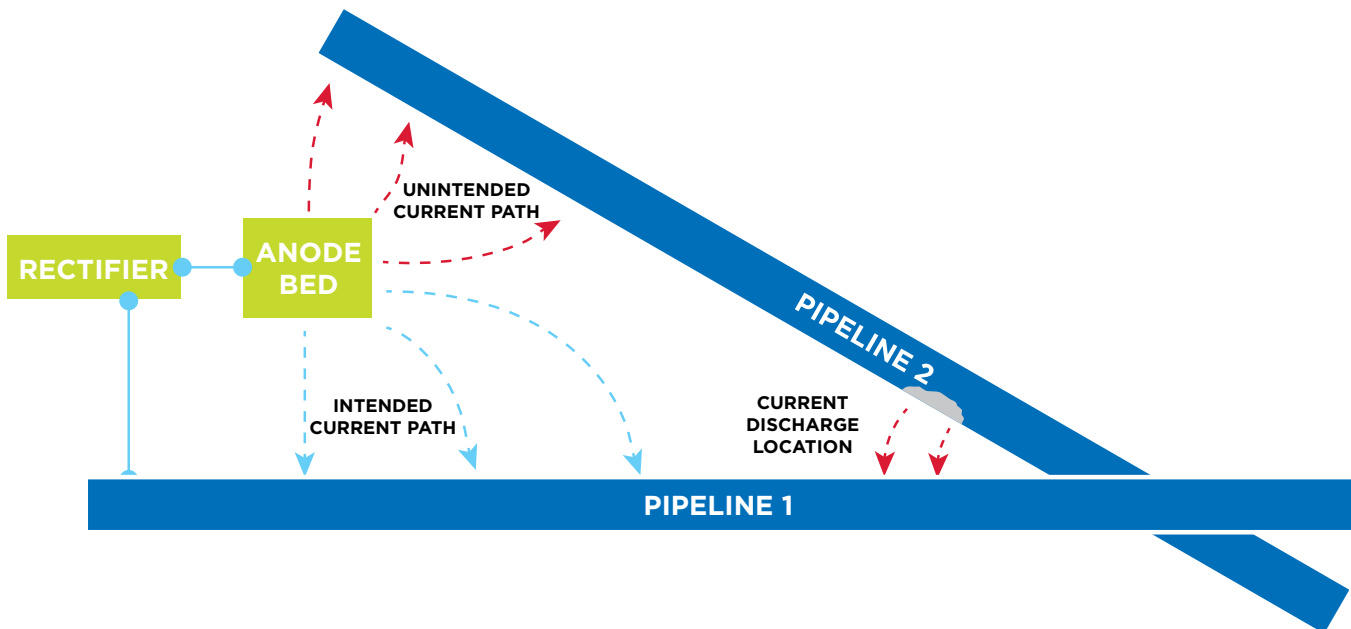
**FIGURE 2:** A nearby metal structure can complicate pipeline cathodic protection systems.

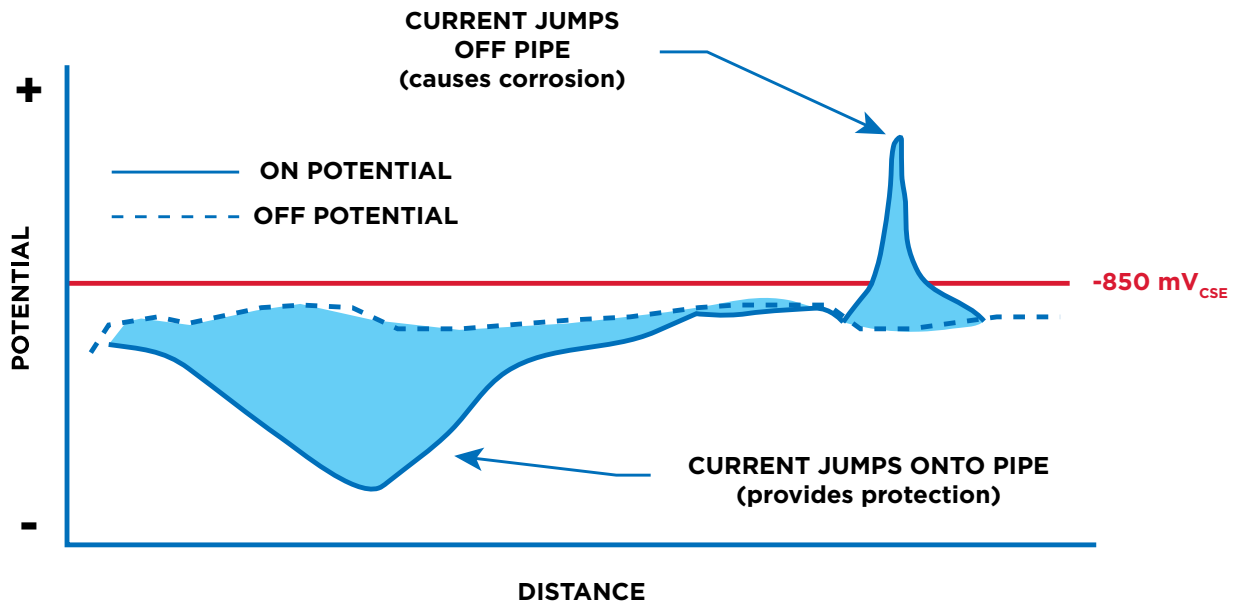
**FIGURE 3:** An example potential profile after surveying a pipeline. This profile would indicate that DC interference is likely occurring.

DC interference can be a silent threat, though it might be detected by routine pipeline surveys (See Figure 3). One possible indication of interference is an unexpected change in the electrical potential (voltage) of an asset at a specific location. This change in potential is especially important if it occurs near a foreign line crossing, although the potential shift could be occurring miles away from the actual crossing location. Also, if a new metal structure is installed near an asset, a survey should be conducted to identify possible interference. Additional monitoring to identify stray current impacts can be done by burying corrosion coupons or mock structures near an asset.
