4 International Clinical Engineering & Health Technology Management Congress

Hospital renovation, Failures in Project coordination and management (the case of CSSD Project in Yaounde – Cameroon

Description

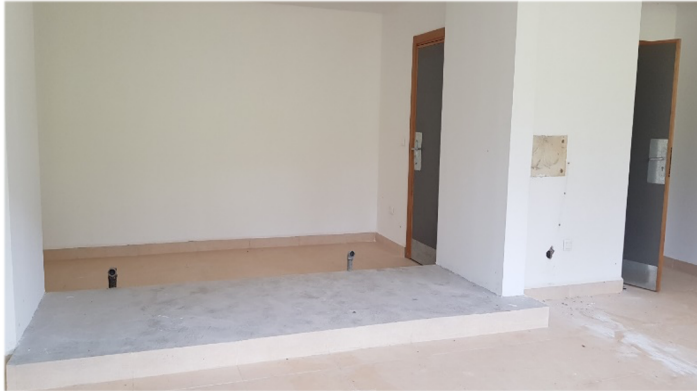
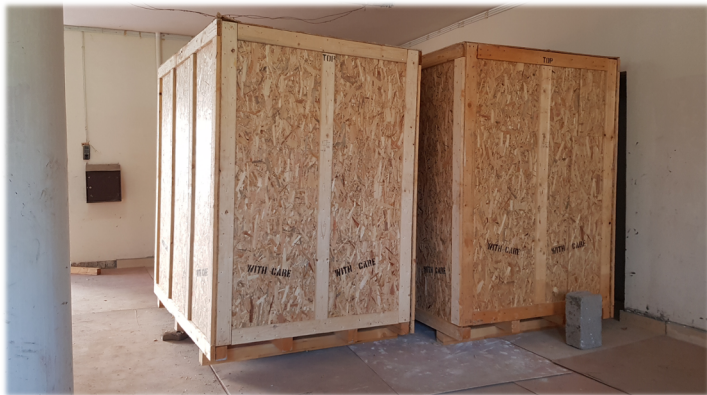
Results

- After one year of follow up, no work was carried out in the CSSD until the arrival of machines on site.
- Poorly executed drains.
- No electrical wiring to various machines installed.
- No water supplies to various machines installed.
- Poor accessibility to the zone with various machines. In order for the machines to enter the building, it necessitated the demolition or enlargement of doors.
- Poor synchronisation of activities lead to the hiring of watch men to guard the machine which were packed out of the building.
