**AN EVALUATION OF THE PERFORMANCE OF**  
**ZRC-221 COLD GALVANIZING COMPOUND**  
**AS WELDING REPAIR PER ASTM A 780 ON**  
**G90 HOT-DIP GALVANIZED STEEL**  
**IN 5% SALT SPRAY**

**Date: July 22, 2009**

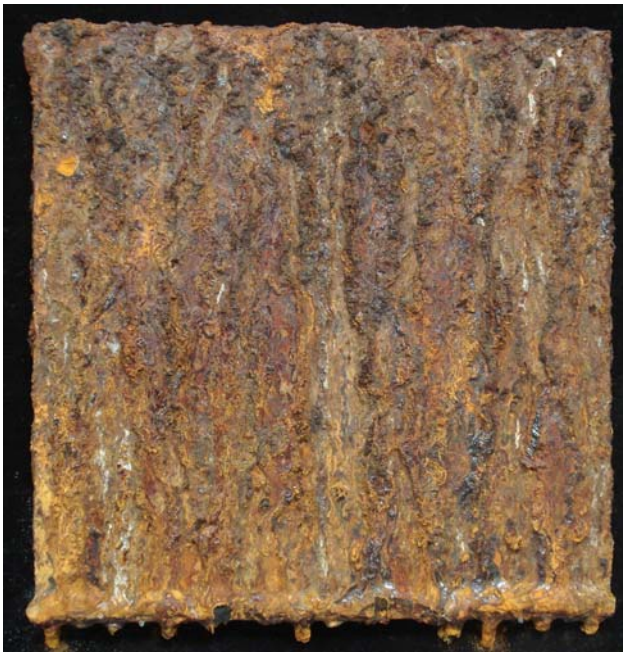
**Figure 1**

**Showing the control test piece after 4000 hours ASTM B 117 Salt Fog Testing.**

The results of this evaluation illustrate that ZRC-221 Cold Galvanizing Compound affords outstanding protection against corrosion to welded and/or damaged areas of G90 hot-dip galvanized steel. Figure 2 shows the condition of the ZRC-221 Cold Galvanizing Compound coated test piece after 4000 hours of ASTM B117 Salt Fog Testing. Figure 1 shows the galvanized control test piece without ZRC-221 applied.

Figure 1 shows the condition of our control test piece, which received no surface preparation before testing. Over the course of 4000 hours salt fog testing, it has formed copious amounts of zinc salt on its surface as a result of the galvanic reaction caused when zinc sacrifices itself to protect the underlying substrate. However, it now exhibits a very significant amount of red rust across its surface, ASTM D 610 Rust Grade 0. The weld itself is totally corroded.

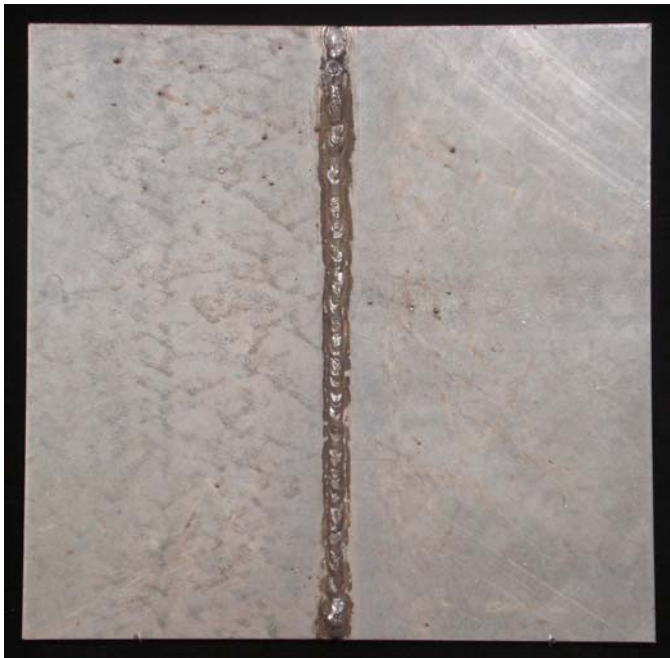
**Figure 3**  
**Showing a representative**  
**test piece after MIG welding.**

In this experiment, 11 gauge panels of G90 specified hot-dip galvanized steel (ASTM A 526) were obtained from Ledford Steel Company, Winchester, KY and employed as the substrate. Two panels of the substrate were MIG-welded together to create the test area. Figure 3 shows the test piece after welding. The welded area was then Power Tool Cleaned (SSPC-SP 11). The surrounding area was Hand Tool Cleaned (SSPC-SP 2). The surface of the whole test piece was then Solvent Cleaned (SSPC-SP 1) using MEK. Figure 4 illustrates the test piece after cleaning.

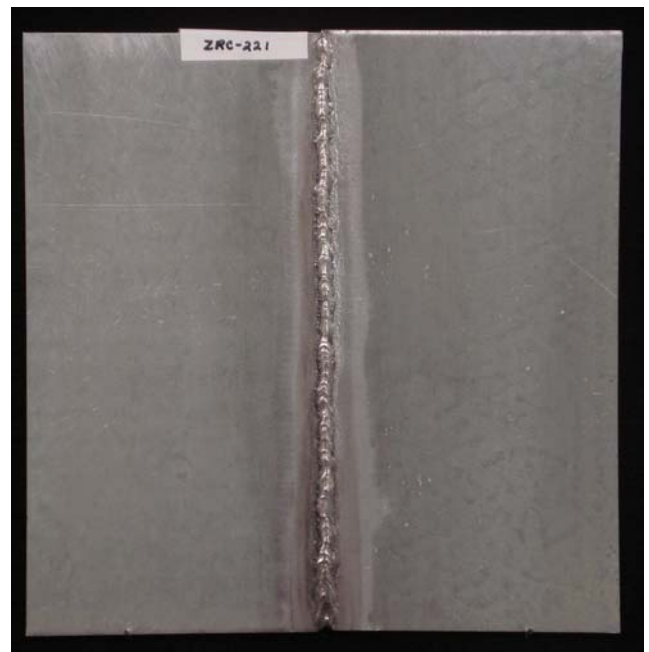
**Figure 4**  
**Showing ZRC-221 test piece**  
**after surface preparation.**

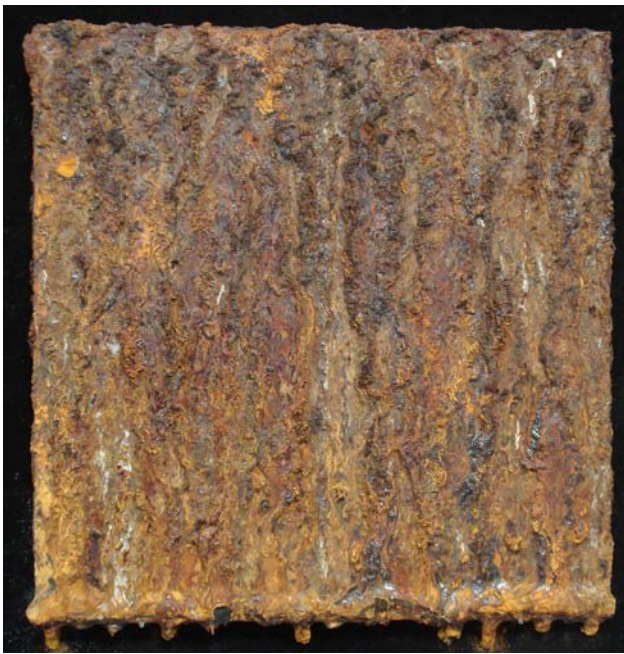
**Figure 1**

**Showing the control test piece after 4000 hours ASTM B 117 Salt Fog Testing.**

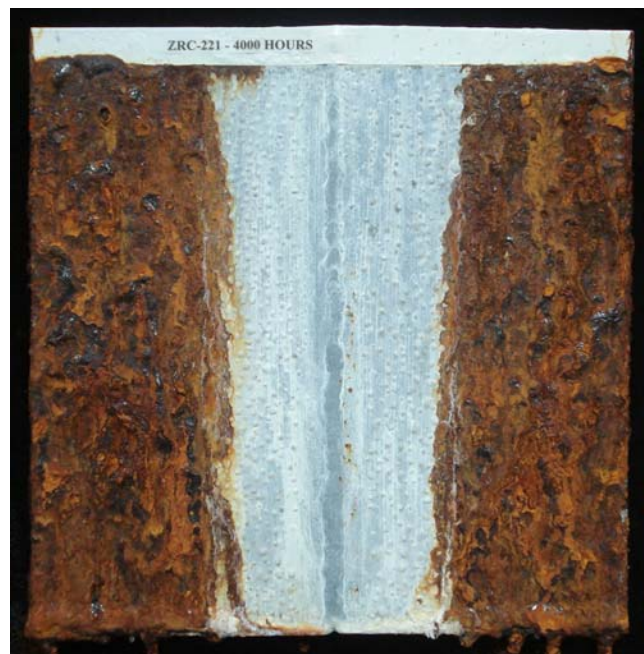
**Figure 2**

**Showing test piece with ZRC-221 applied after 4000 hours ASTM B 117 Salt Fog Testing.**

Figure 2 shows the condition of the ZRC-221 Cold Galvanizing Compound coated test piece. On the uncoated area of the hot-dip galvanizing, similar to the control test piece, this panel has also formed copious amounts of zinc salt, followed by very significant amounts of red rust, ASTM D 610 Rust Grade 0.

However, where ZRC-221 has been applied to the weld and surrounding area, there is light formation of zinc hydroxycarbonate salt, typical of bonafide zinc rich coatings, and a few very small rust spots just beginning to show on the right edge of the weld. No blistering was observed on the weld. Medium blistering was observed across the ZRC-221 surface, ASTM D 714 6-M.
