Periodic Condition Report

Inspected on June 22, 2020 9:37 AM

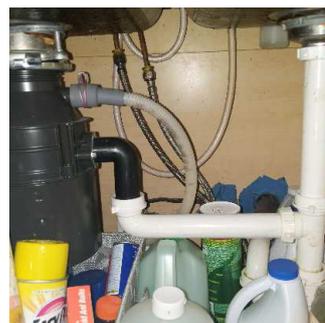
Under the sink
06/22/2020 10:31 AM

Items	Values	Notes
Appliances Cleanliness	Condition: Clean	
Countertop cleanliness	Condition: Clean	
Under the sink	Status: All good	
Window / Blinds / Screens	Status: All good	
Other Issues	Status: All good	
General Cleanliness	Condition: Clean

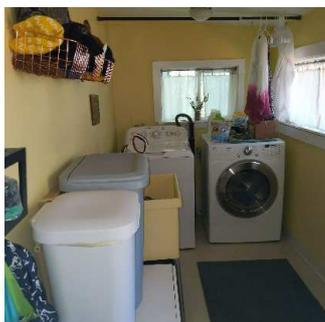
Overview Photos
06/22/2020 10:32 AM

Items	Values	Notes
Water Damage	Status: All good	
Window / Blinds / Screens	Status: All good	
CO / Smoke Detector Battery Check	Condition: Not present	
Other Issues	Status: Noticeable issue(s)	tenon says bottom lock not working properly
General Cleanliness	Condition: Clean

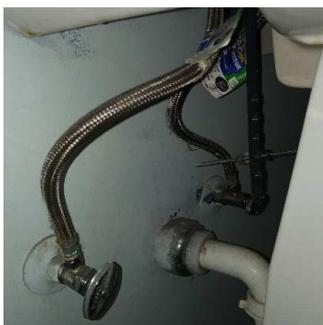
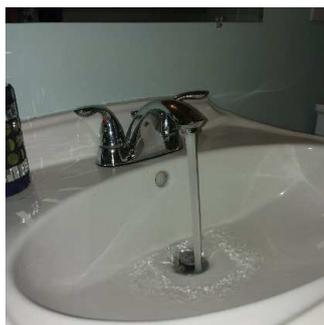
Faucet & Sink (1/2)
06/22/2020 10:35 AM

Faucet & Sink (2/2)
06/22/2020 10:36 AM

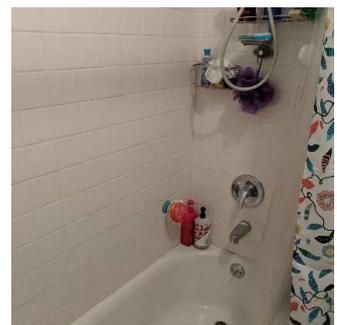
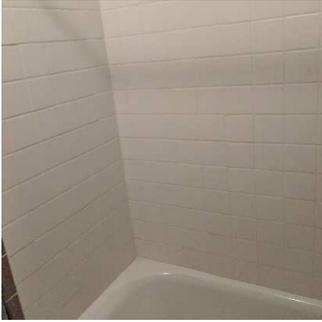
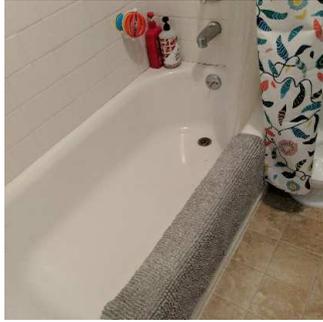
Tub / Shower (1/3)
06/22/2020 10:37 AM

Tub / Shower (2/3)
06/22/2020 10:37 AM

Tub / Shower (3/3)
06/22/2020 10:37 AM

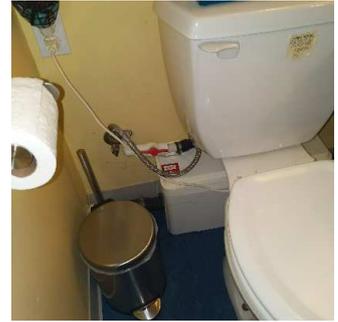
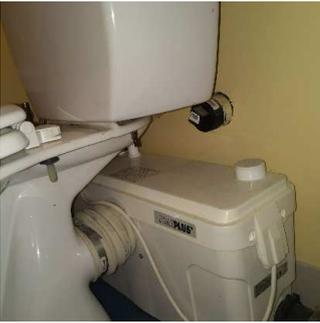
Toilet (1/2)
06/22/2020 10:50 AM

Toilet (2/2)
06/22/2020 10:50 AM

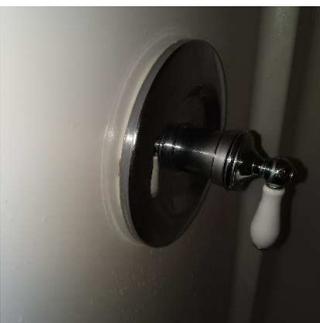
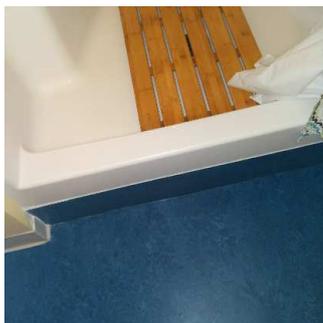
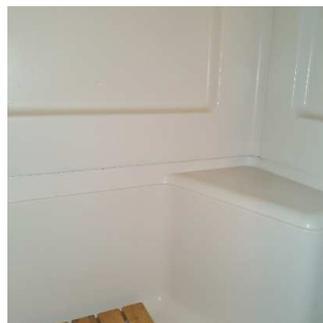
Items	Values	Notes
Toilet	Status: All good	no leaks
Faucet & Sink	Status: All good	sink drains but slow - I think it's due to the zoom drain setup and normal for this type of configuration
Under the sink	Status: All good	
Tub / Shower	Status: All good	
Tiles / Grout	Status: All good	no tile , seals in tact
Ventilation Source (Fan)	Status: All good	fan is a little noisy but works well
Window / Blinds / Screens	Status: All good	
Other Issues	Status: All good	
General Cleanliness	Condition: Clean

Tiles / Grout (1/3)
06/22/2020 10:53 AM

Tiles / Grout (2/3)
06/22/2020 10:53 AM

Tiles / Grout (3/3)
06/22/2020 10:54 AM

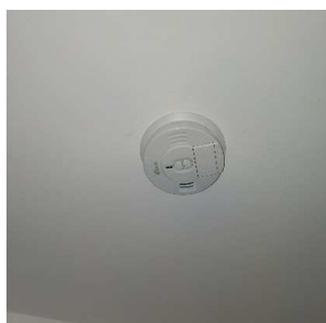
CO / Smoke Detector Battery Check
06/22/2020 10:43 AM

Items	Values	Notes
Water Damage	Status: All good	
Window / Blinds / Screens	Status: All good	
CO / Smoke Detector Battery Check	Condition: Operable	
Other Issues	Status: All good	
General Cleanliness	Condition: Clean

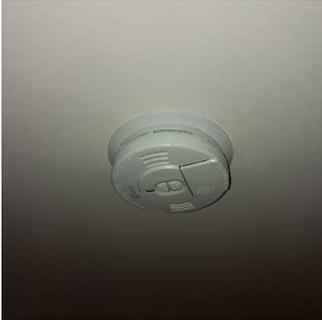
CO / Smoke Detector Battery Check
06/22/2020 11:08 AM

Items	Values	Notes
Water Damage	Status: All good	
Window / Blinds / Screens	Status: All good	
CO / Smoke Detector Battery Check	Condition: Operable

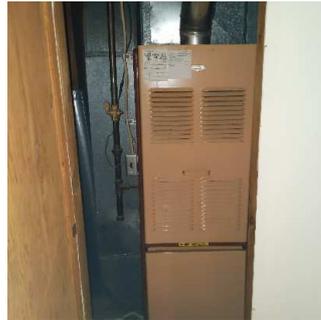
Furnace Filter (1/3)
06/22/2020 11:01 AM

Items	Values	Notes
Garage Door	Status: All good	
Water Damage	Status: All good	
Window / Blinds / Screens	Status: Noticeable issue(s)	window broken
Furnace Filter	Condition: Dirty	it appears furnace has not been serviced in some time The filter also looks older and should probably be replaced
Other Issues	Status: All good	
General Cleanliness	Condition: Clean

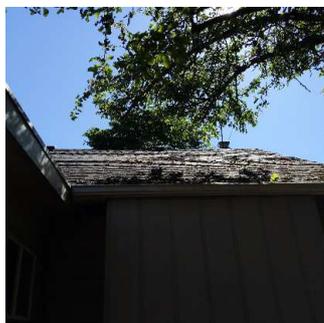
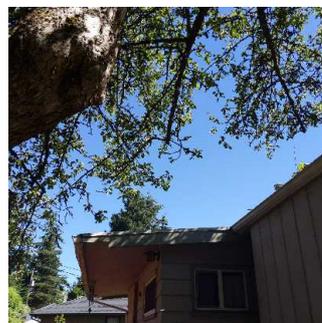
Tree Branches - nothing too close or hanging over the property (1/2)
06/22/2020 10:20 AM

Tree Branches - nothing too close or hanging over the property (2/2)
06/22/2020 10:20 AM
