C5B Technical Annex 02

Trunk Mains and Pipe Bridges Investment

Technical Approach and Business Case

NTPBP-INV-TRU-0526

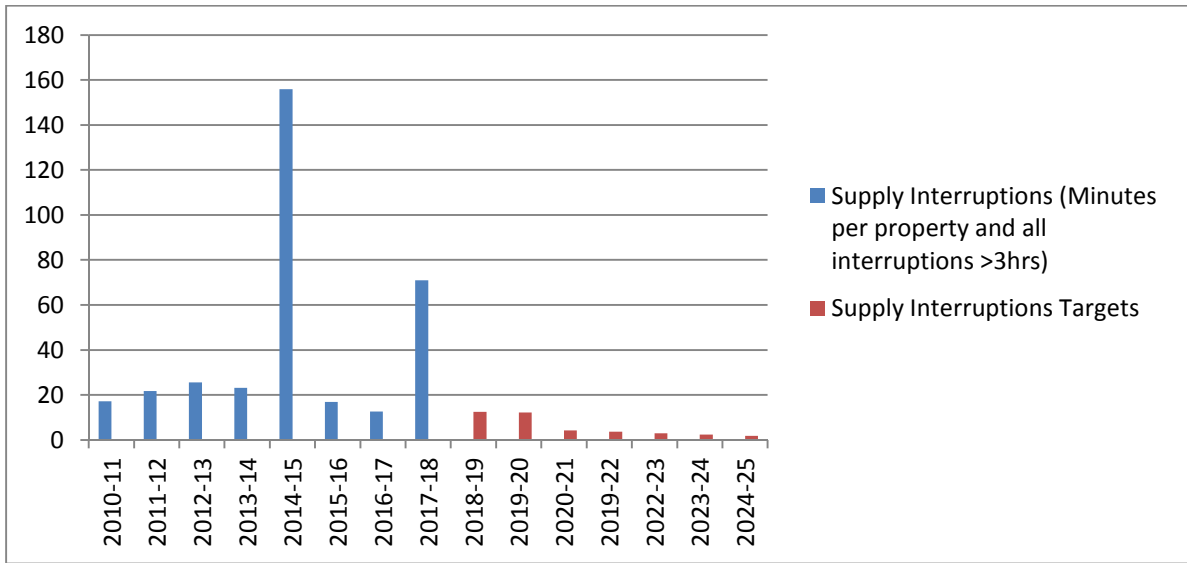
Figure 2: Historic Supply Interruptions

Historic supply interruptions are shown in Figure 2 below, together with the targets for AMP6 and AMP7.

The peaks in supply interruptions in 2014/15 and 2017/18 are attributable to just four incidents. When these outliers are removed from the data, the underlying trend shows historic improvement across AMP6, as shown below in Figure 3.

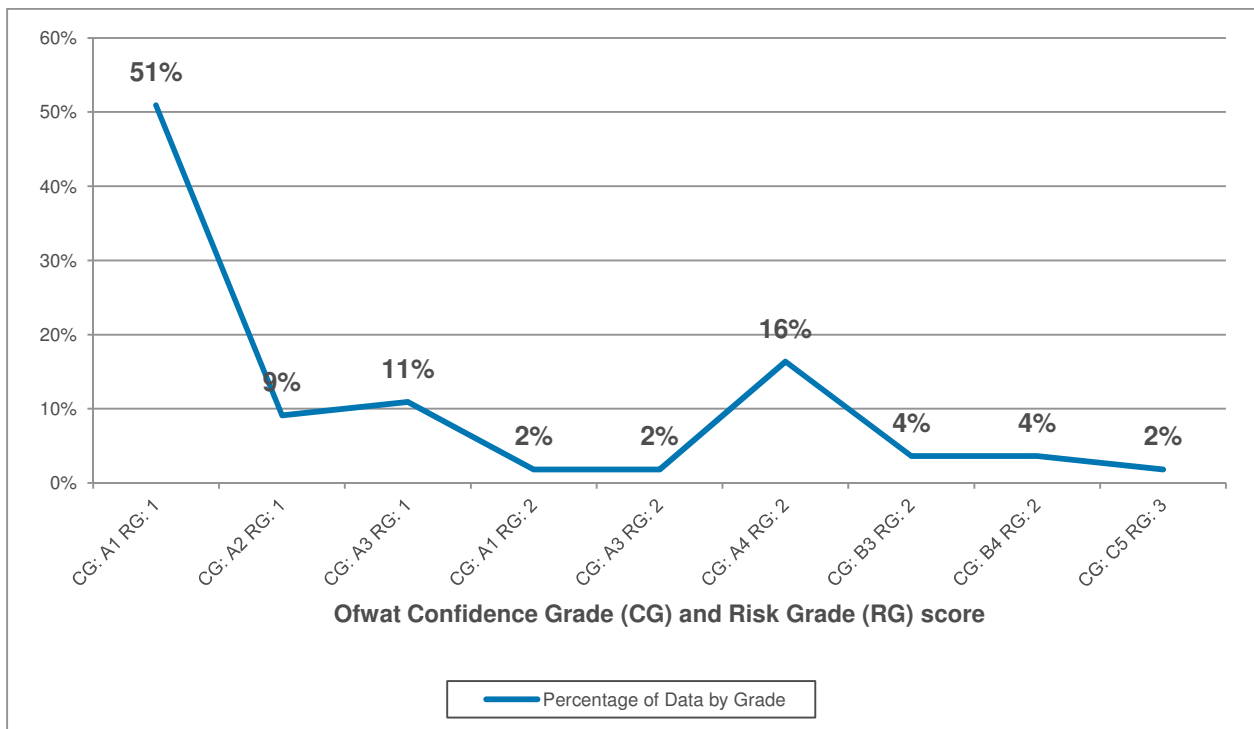
Figure 8: Percentage of Data Types by Ofwat Confidence Grade and Risk Grade

Figure 8 summarises the number of data types scored against Ofwat Confidence Grades and Risk Grades.
