AN EVALUATION OF THE PERFORMANCE OF
GALVILITE GALVANIZING REPAIR COMPOUND
AS WELDING REPAIR PER ASTM A 780 ON
G90 HOT-DIP GALVANIZED STEEL
IN 5% SALT SPRAY

Date: July 22, 2009

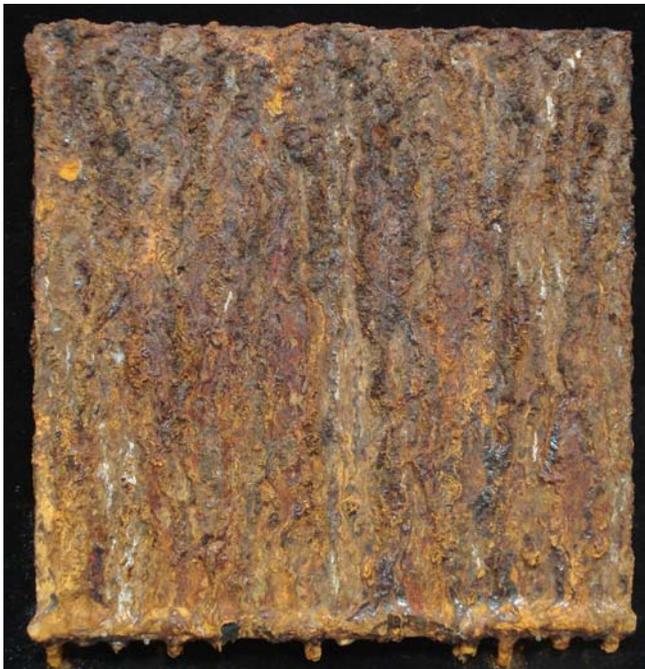
Showing the control test piece after 4000 hours ASTM B 117 Salt Fog Testing.

The results of this evaluation illustrate that Galvilite Galvanizing Repair Compound affords outstanding protection against corrosion to welded and/or damaged areas of G90 hot-dip galvanized steel. Figure 2 shows the condition of the Galvilite Galvanizing Repair Compound coated test piece after 4000 hours of ASTM B117 Salt Fog Testing. Figure 1 shows the galvanized control test piece without Galvilite applied.

Figure 1 shows the condition of our control test piece, which received no surface preparation before testing. Over the course of 4000 hours salt fog testing, it has formed copious amounts of zinc salt on its surface as a result of the galvanic reaction caused when zinc sacrifices itself to protect the underlying substrate. However, it now exhibits a very significant amount of red rust across its surface, ASTM D 610 Rust Grade 0. The weld itself is totally corroded.

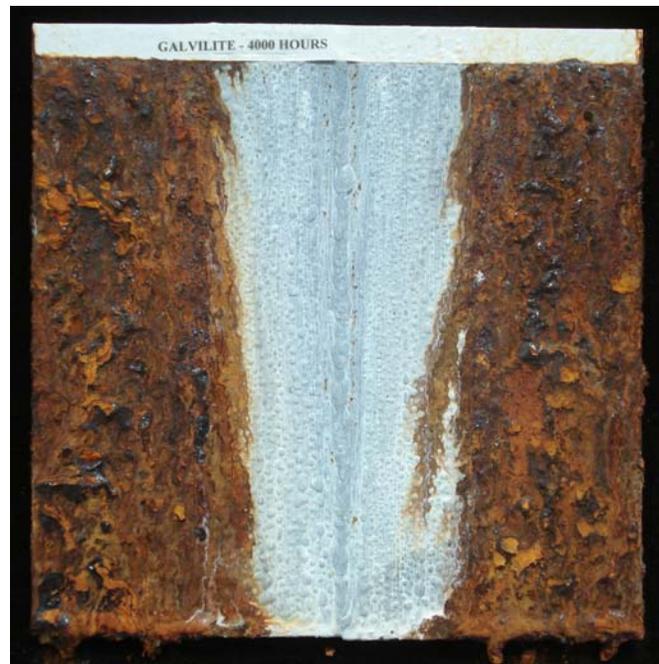
Showing test piece with Galvilite applied after 4000 hours ASTM B 117 Salt Fog Testing.

Figure 2 shows the condition of the Galvilite Galvanizing Repair Compound coated test piece. On the uncoated area of the hot-dip galvanizing, similar to the control test piece, this panel has also formed copious amounts of zinc salt, followed by very significant amounts of red rust, ASTM D 610 Rust Grade 0.

However, where Galvilite has been applied to the weld and surrounding area, only light formation of zinc hydroxycarbonate salt, typical of bonafide zinc rich coatings, has occurred and a few very small rust spots just beginning to show on the edges of the welds. No blistering was observed on the weld. Medium blistering was observed across the Galvilite-coated surface (ASTM D 714 6-MD) with slightly larger blisters at the interface between Galvilite and the uncoated hot-dip galvanizing, ASTM D 714 4-MD, seemingly caused by the formation and bleeding-over of copious amounts of zinc salt.

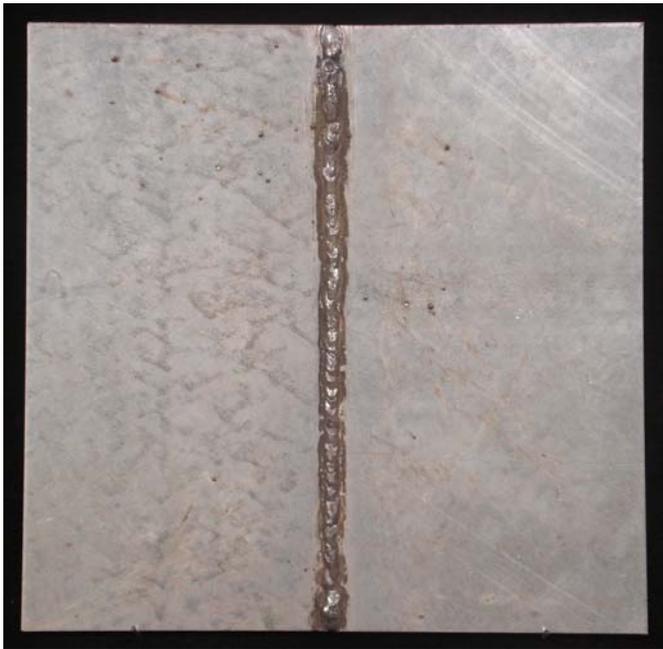
Figure 3
Showing a representative
test piece after MIG welding.

In this experiment, 11 gauge panels of G90 specified hot-dip galvanized steel (ASTM A 526) were obtained from Ledford Steel Company, Winchester, KY and employed as the substrate. Two panels of the substrate were MIG-welded together to create the test area. Figure 3 shows the test piece after welding. The welded area was then Power Tool Cleaned (SSPC-SP 11). The surrounding area was Hand Tool Cleaned (SSPC-SP 2). The surface of the whole test piece was then Solvent Cleaned (SSPC-SP 1) using MEK. Figure 4 illustrates the test piece after cleaning.

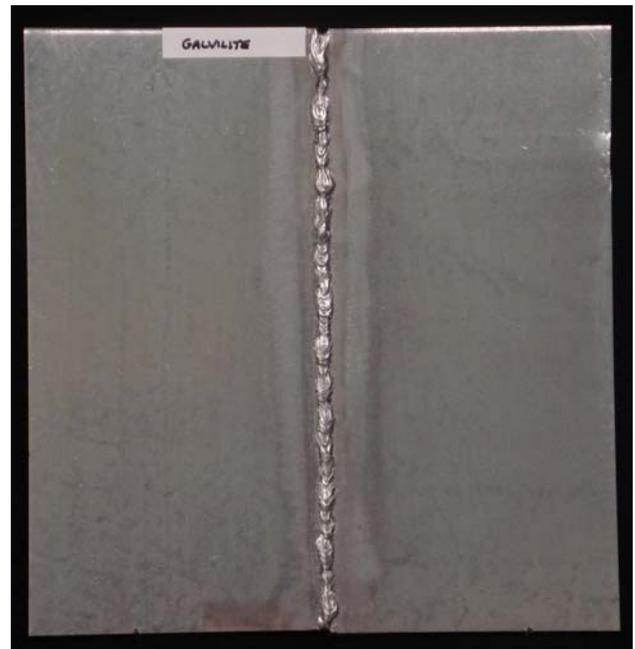
Figure 4
Showing Galvilite test piece
after surface preparation.

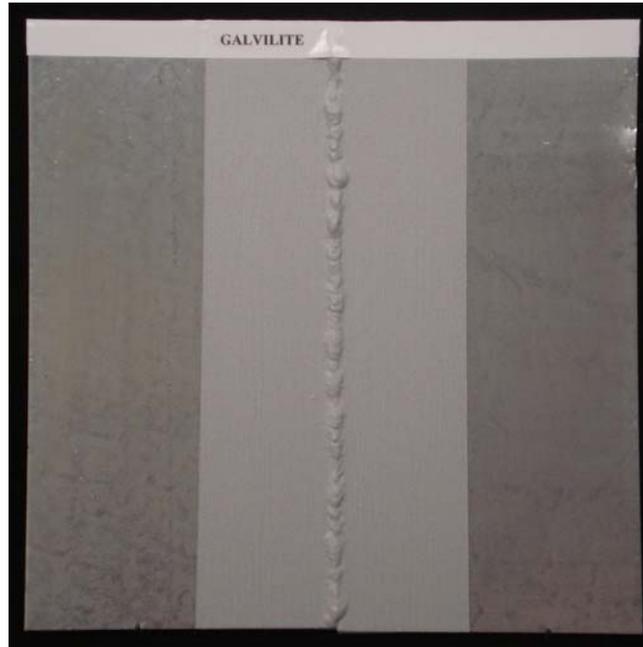
Figure 5
Showing test piece after application of Galvilite.

Two coats of Galvilite were applied from a randomly chosen can (after stirring) by brush to a total dry film thickness of 3.6 mils (recorded with a Positector 6000 series magnetic film thickness gauge, per SSPC-PA 2), allowing a 24-hour dry time at 25°C between coats. ZRC was overlapped 1.5 inches over the galvanized surface on either side of the weld. Figure 5 shows the panel after Galvilite application.

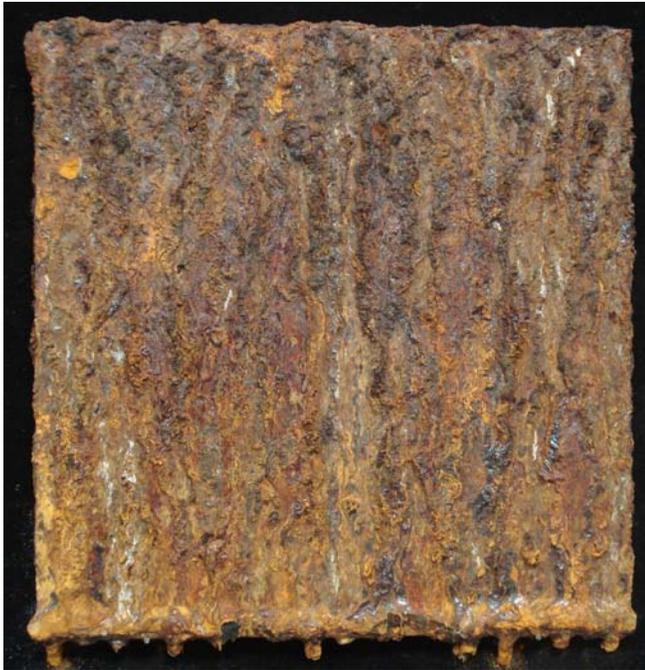
Figure 1

Showing the control test piece after 4000 hours ASTM B 117 Salt Fog Testing.

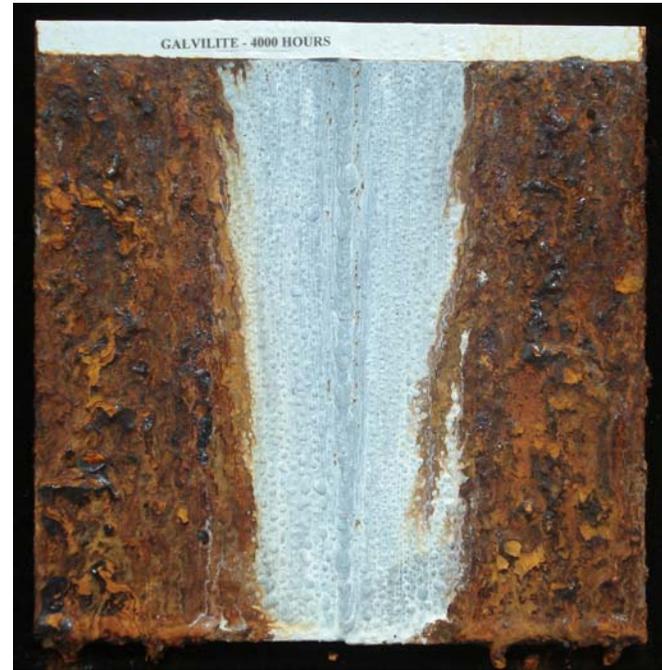
Figure 2

Showing test piece with Galvilite applied after 4000 hours ASTM B 117 Salt Fog Testing.
