# Monitoring Cyanobacteria in Grahamstown Dam

Evaluating Hunter Water's actions to ensure drinking water remains safe

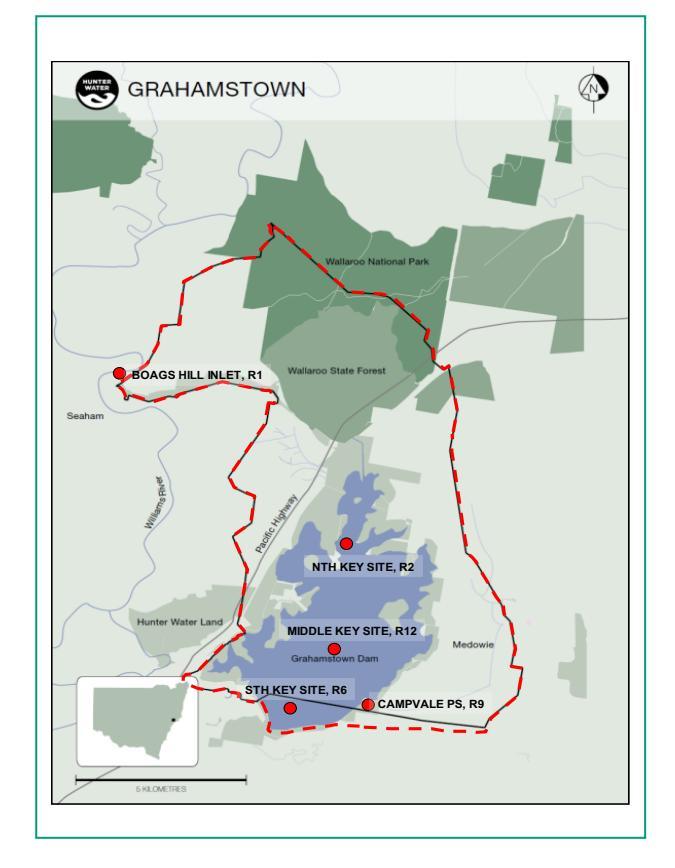
Figure 1: Key Routine Monitoring Sites in Grahamstown Dam Catchment

Routine algae monitoring locations within Grahamstown Dam catchment are the Dam's key northern (R2), middle (R12) and southern (R6) locations, Campvale Pump Station (R9) and Boags Hill at Seaham Weir (R1) (Figure 1). The raw water offtake is located near the Dam's key southern monitoring location R6. To protect drinking water quality, public access to Grahamstown Dam is minimised for recreational purposes.

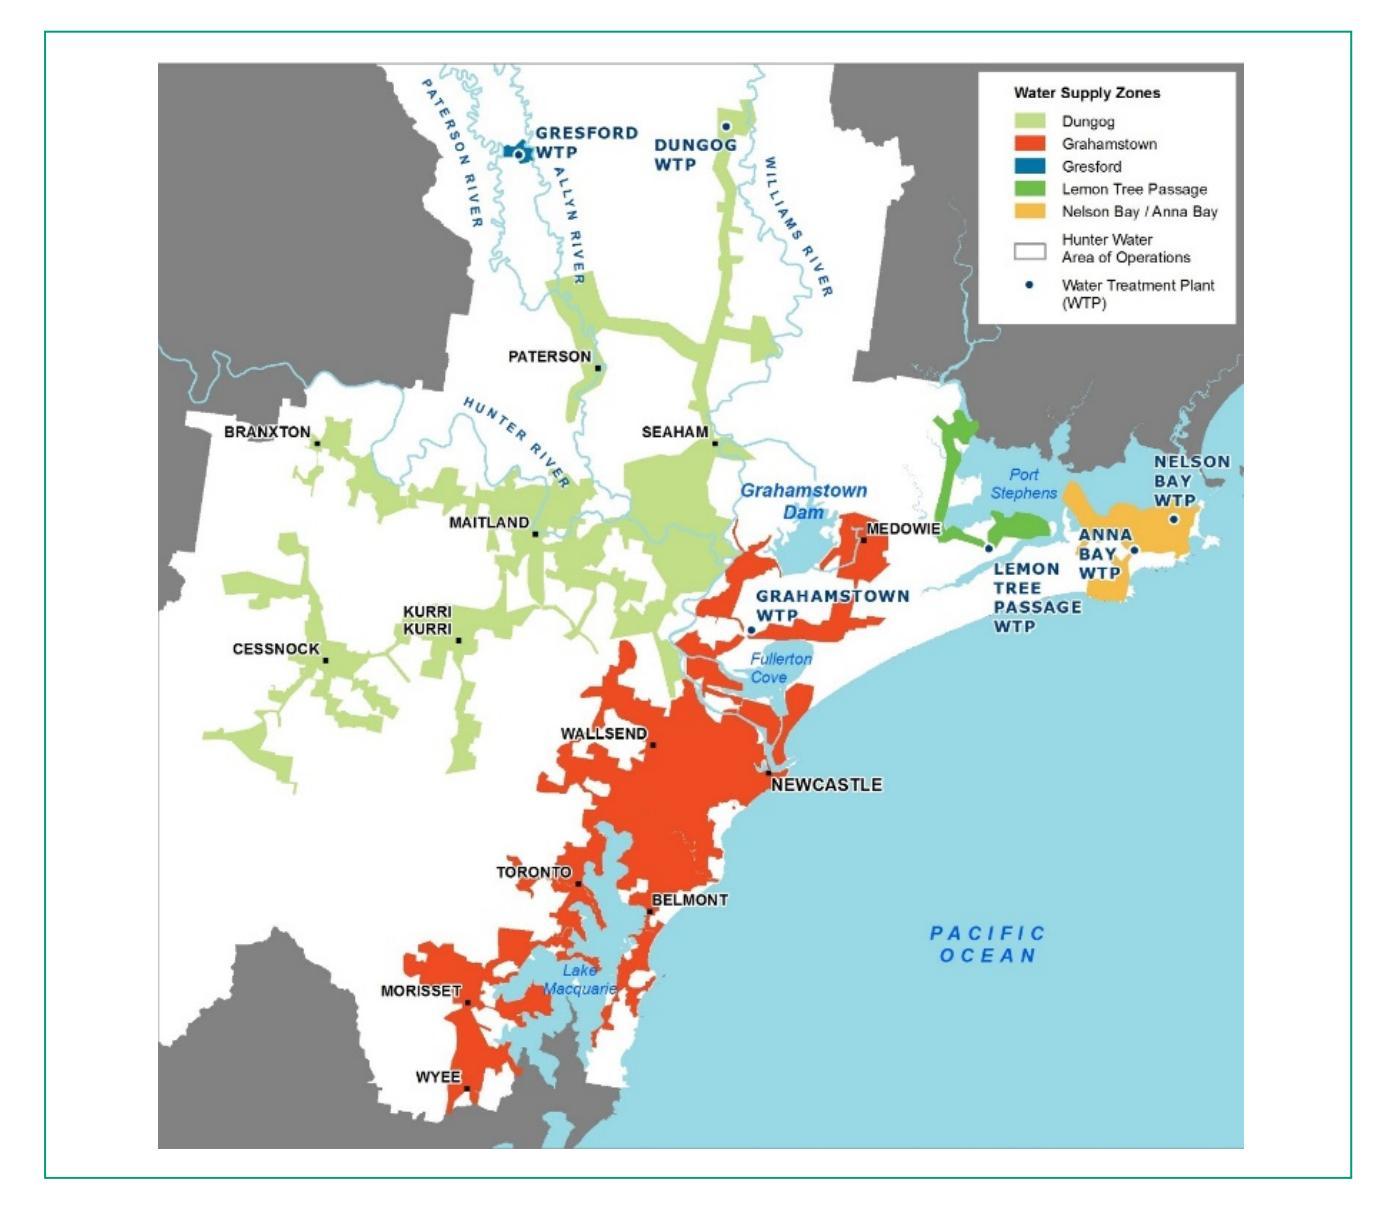
Figure 2: Overview of Hunter Water's Drinking Water Supply System

Grahamstown Dam supplies raw water to Grahamstown WTP, Hunter Water's largest WTP, to supply drinking water to a population of 400,000 people in the Lower Hunter Region of NSW (Figure 2). Grahamstown WTP uses conventional treatment processes, which includes coagulation/flocculation, sedimentation, filtration, pH correction, disinfection and fluoridation. A Powdered Activated Carbon (PAC) dosing facility is located at Grahamstown Dam immediately downstream of the raw water offtake and five kilometres north of Grahamstown WTP. This Dam and associated WTP are critically important to Hunter Water as it is not possible to meet customer demand outside of winter without extraction from this source, which can meet up to 75% of Hunter Water's water supply requirements on a high-usage day.

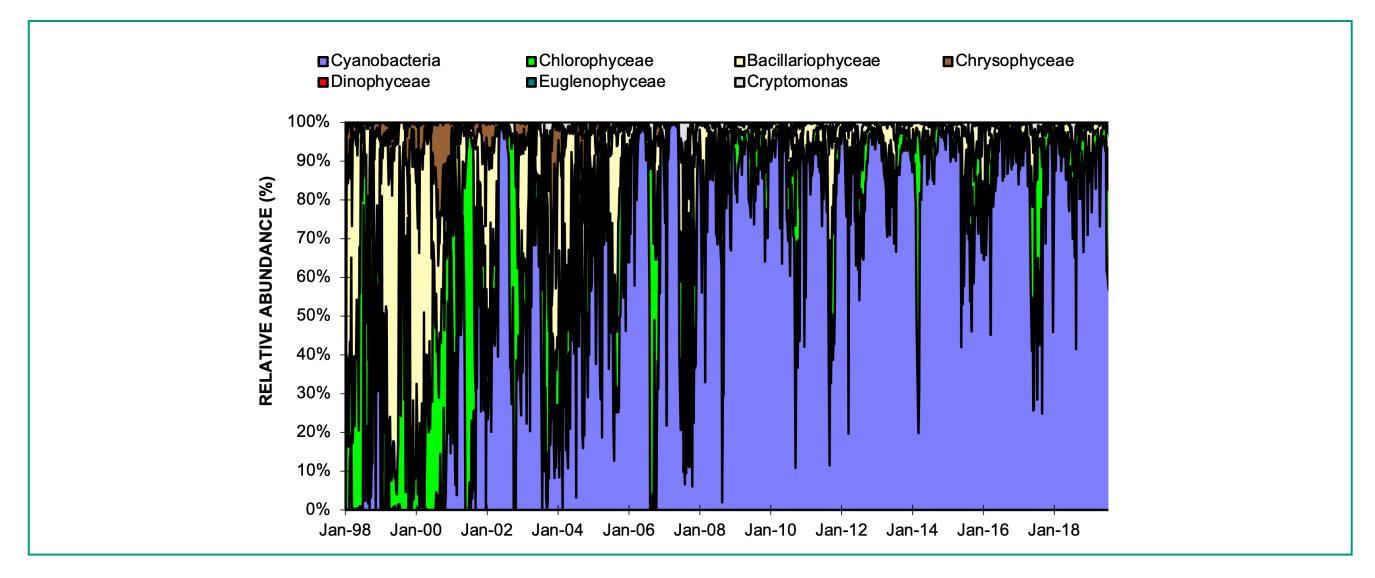
Figure 3: Historical Relative Abundance of Major Algae Groups in Grahamstown Raw Water

Cyanobacteria can produce objectionable taste and odour compounds, such as geosmin, and toxins that can pose potential health hazards to freshwater systems and supply of safe drinking water. Historical water quality monitoring data show a gradual increase in relative abundance of cyanobacteria in Grahamstown raw water (Figure 3) with occasional spikes in *Dolichospermum* and *Microcystis* levels for short periods without resulting in a major algae bloom.

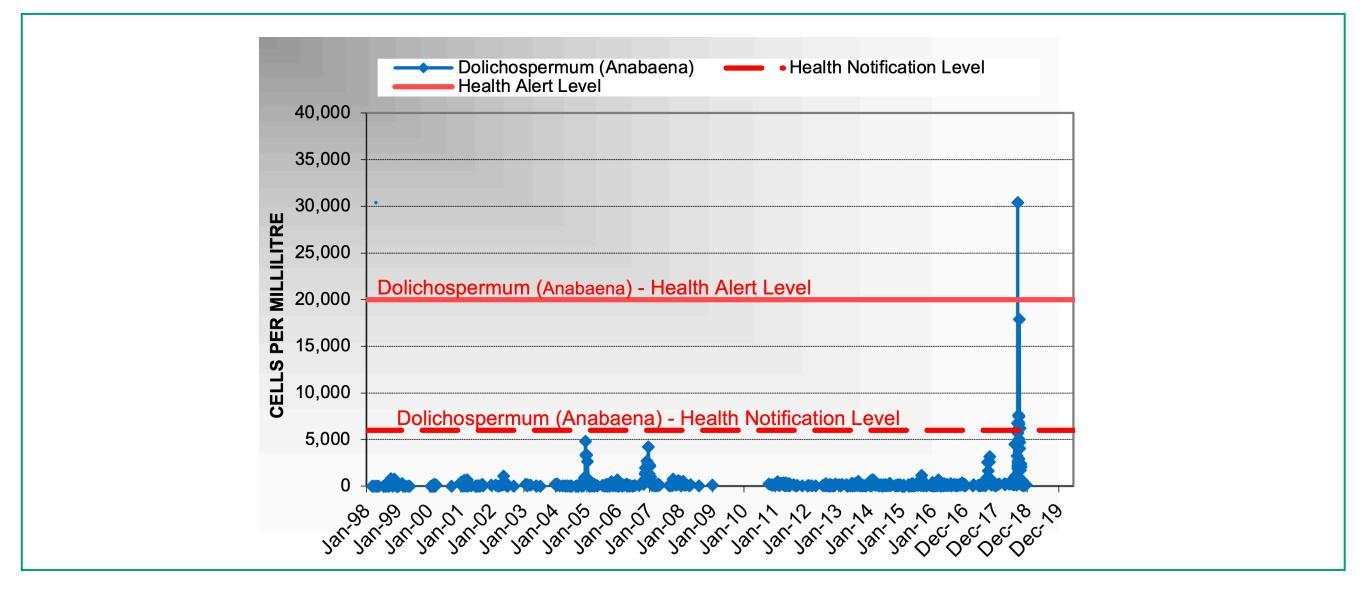
Figure 4: Historical Dolichospermum Levels in Grahamstown Raw Water

The highest counts for *Dolichospermum* and *Microcystis* recorded in the Grahamstown raw water prior to this incident were 4800 cells/mL in December 2004 and 6600 cells/mL in December 2012, respectively (Figure 4 and Figure 5).

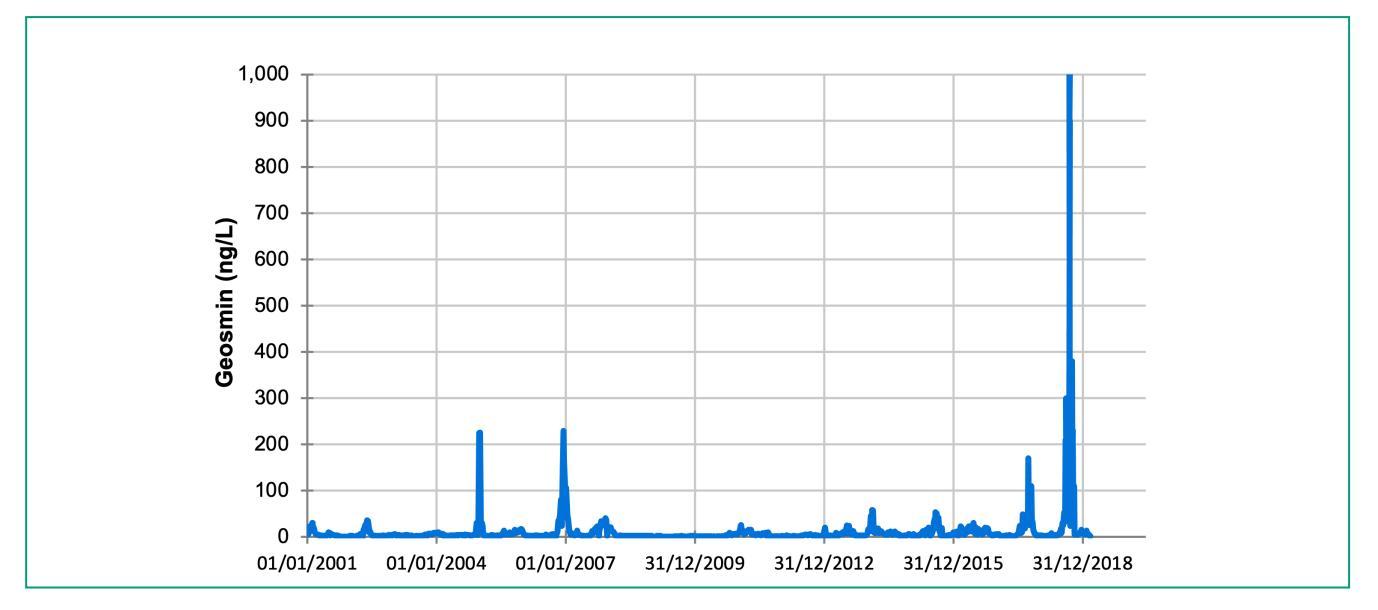
Figure 6: Historical Geosmin Levels in Grahamstown Raw Water

observed prior to commencing the PAC dosing. Prior to this, the highest geosmin level recorded in Grahamstown raw water was 229 ng/L in December 2006 (Figure 6). The high level of removal in the conventional treatment process is an

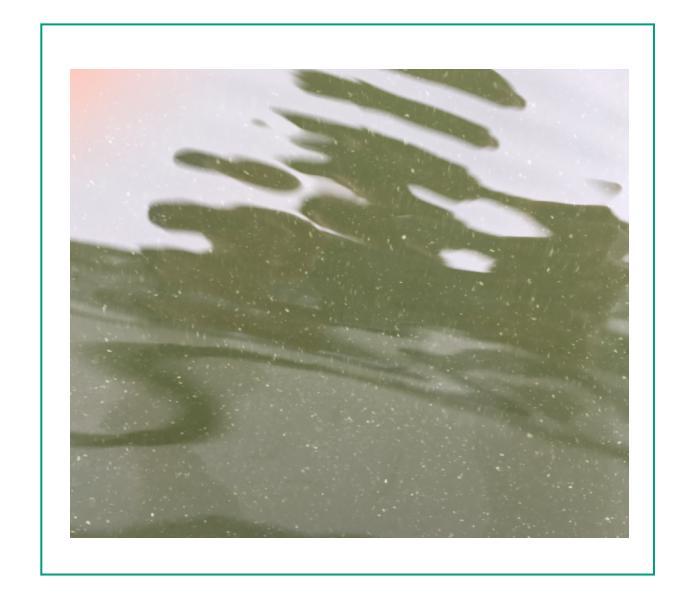
Figure 7: Presence of Algae in Grahamstown Dam near Raw Water Offtake Area

Geosmin levels in Grahamstown raw water started to rise notably in the first week of September. On 5 September 2018, Hunter Water rangers reported an algae scum near the spillway in the northern part of Grahamstown Dam (Figure 7). No algae scums were observed the next day. Wind direction in the dam impacted positioning of algae scums and, in turn, the measured algae levels in raw water supplied to Grahamstown WTP. Cyanobacteria results from the dam and raw water samples collected earlier in the week were well below Australian Drinking Water Guidelines (ADWG, 2011) notifications levels (cells/mL) for *Dolichospermum circinale* (6,000) and *Microcystis aeruginosa* (2,000).

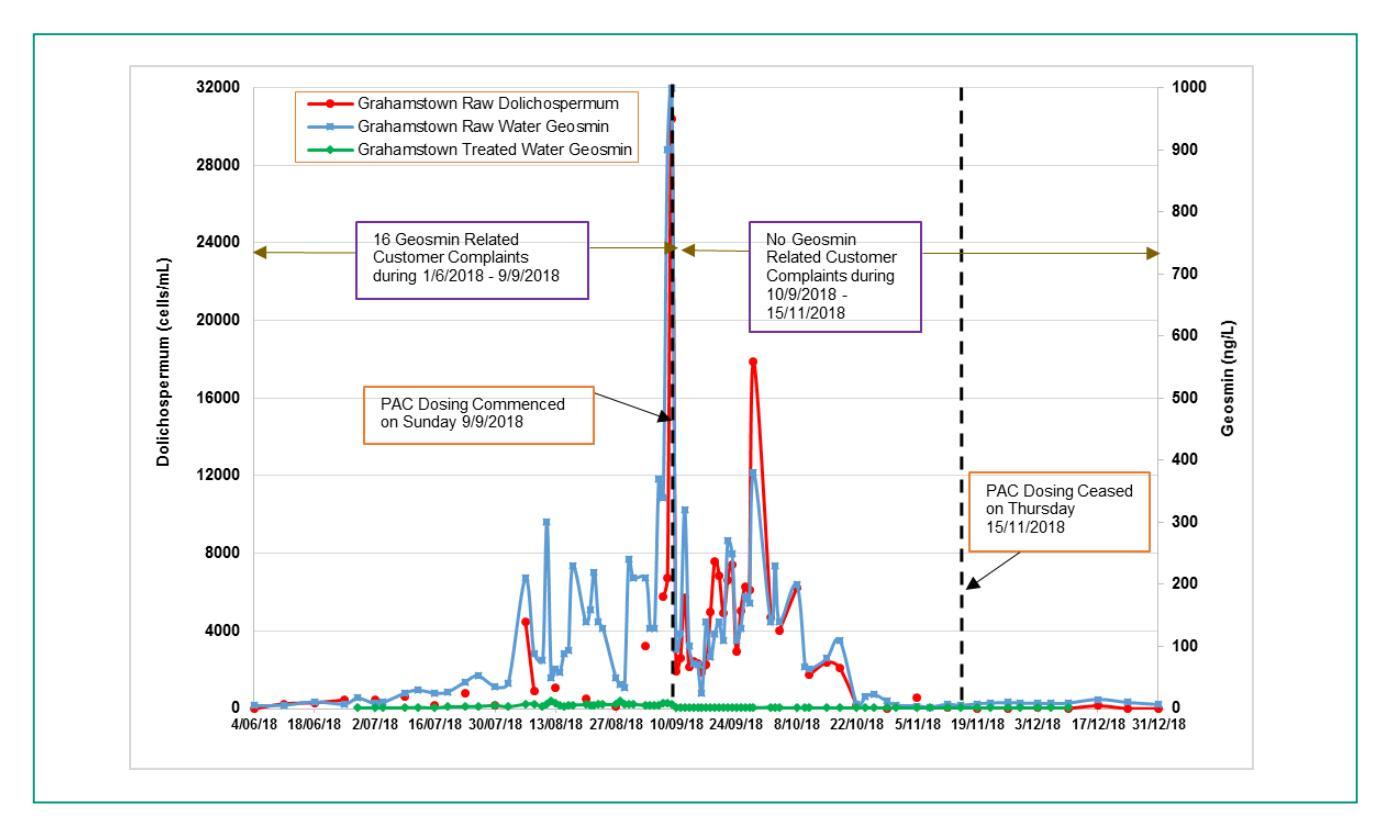
Figure 8: Dolichospermum and Geosmin Levels in Grahamstown Raw Water during Algae Bloom

On 8 September, algae monitoring in Grahamstown Dam and WTP continued with raw water *Dolichospermum* levels of 6750 cells/mL, which exceeded the health notification level of 6000 cells/mL. Elevated levels of *Dolichospermum*  *circinale* (up to 30,400 cells/mL) and geosmin (up to 1000 ng/L) were detected in raw water samples collected on 9 September (Figure 8).

On 9 September 2018, Hunter Water notified NSW Health of these results and commenced PAC dosing. Hunter Water declared a Major Incident, and an Incident Management Team was established. Public access to the dam for recreational activities was ceased, and customers extracting untreated dam water were advised of the issue and told to refrain from using it for irrigation and livestock. Leading up to 8 September, monitoring was being undertaken as per Hunter Water's Cyanobacterial Framework for Potable and Environmental Waters and, in addition, more frequent monitoring of Grahamstown Dam and WTP locations was also carried out as necessary. Water NSW was also notified of these results as part of Hunter Water's Cyanobacterial Framework for Environmental Waters.
