PROJECT PROFILE H-Frame Wood Pole Restorations

Real Situations and Custom Wood Transmission Pole Restoration Solutions

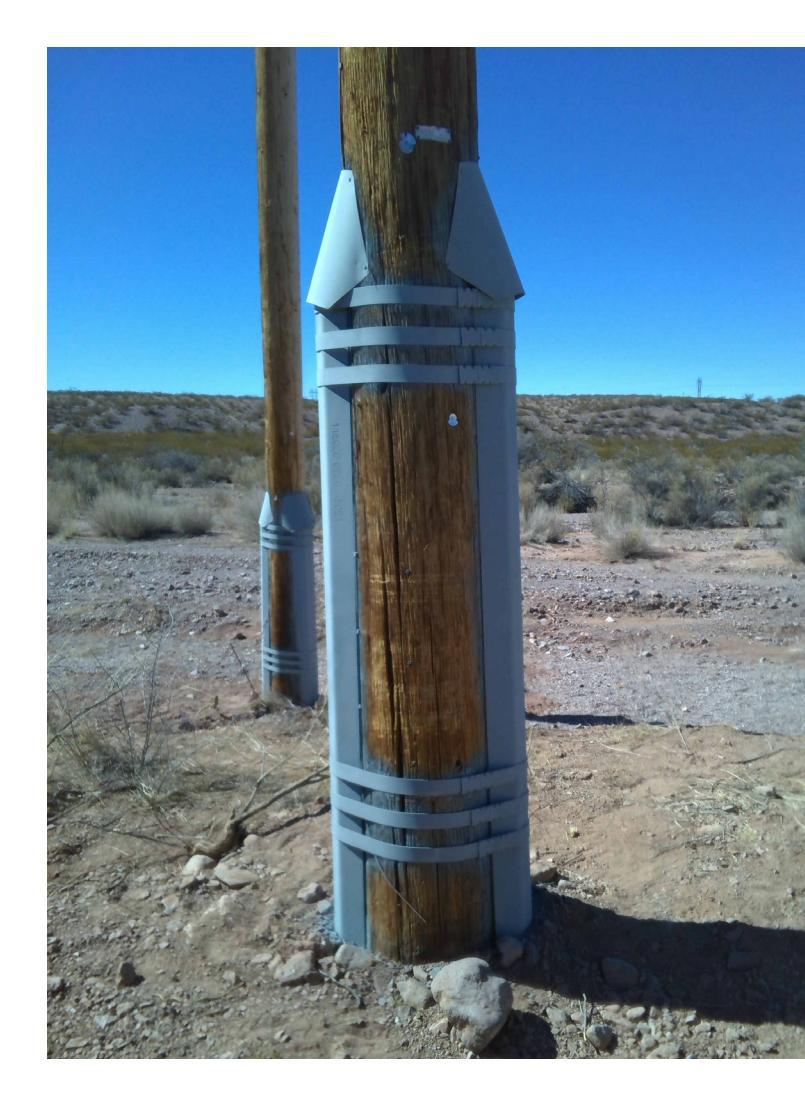
A southwestern utility had H-frame transmission poles located in a remote desert area. The customer reported structures at risk of reduced foundation capacity due to environmental erosion which had caused several feet of soil loss surrounding these structures. Osmose worked jointly with the utility's engineering team on the best solutions to mitigate risk.

Each pole of the H-frame transmission structures was assessed for length, class, and current conditions such as remaining embedment depth, lean, and current soil surroundings. Based on these findings, Osmose determined that each pole would receive custom steel truss solutions of either 17 or 20 feet in total length, depending on the pole's remaining embedment depth. These trusses were driven into the soil to 10 and 13 feet, respectively, which is approximately 5 feet past the butt of the embedded pole. Two trusses were installed per pole, one on either side, and permanently banded to the pole above ground to firmly affix the foundation improvement solution to the in-service pole. Working closely with the utility, Osmose was able to

design and install a robust solution without the need for an outage that significantly reduced pole turnover risk and increase the resiliency for the utility.

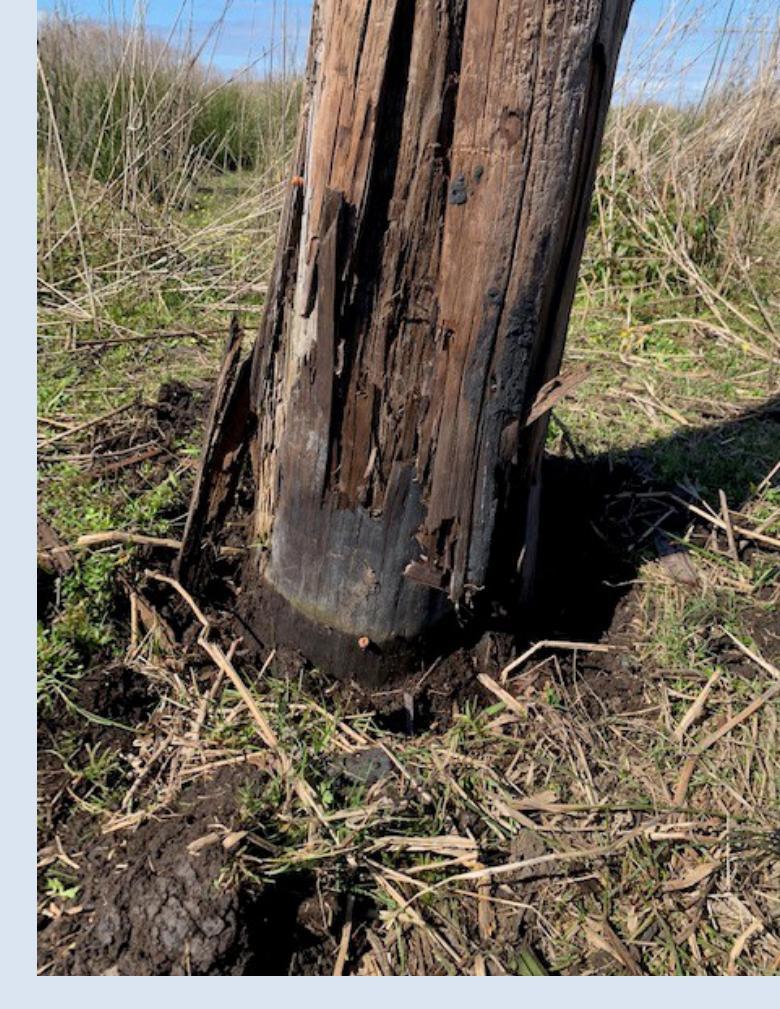
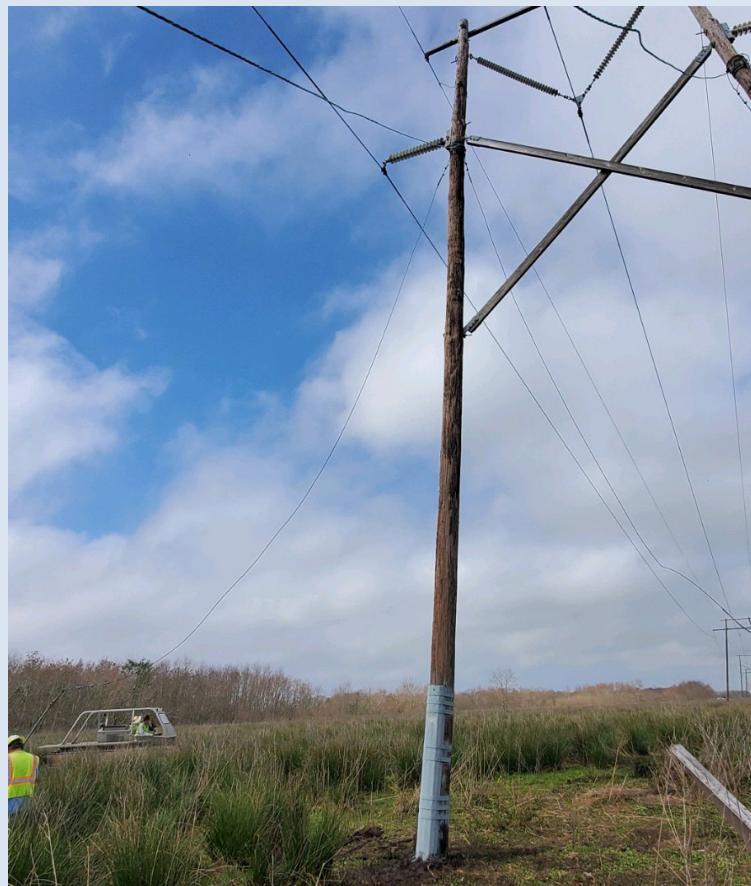
Due to the remoteness of this utility's assets in the wetlands of the southeastern United States, the utility uses aerial patrol inspections. Upon footage review, the utility identified significant deterioration of a critical structure and requested a follow-up in-person inspection of the structure using an Osmose wood pole inspector. The ground line inspection confirmed significant deterioration at the groundline which typically would require immediate replacement.

Working closely with the utility, Osmose formulated a plan to safely mobilize a crew and bring in special equipment (marsh master with a sled to carry all restoration materials, equipment, and tools). For extra precaution given the severity of the pole condition and significance of this project, the utility dispatched a third-party safety observer and a flex track vehicle with a grappler to support the pole while being restored. Osmose installed two 13-foot long C-Trusses per pole that provided the full restoration strength to the ground line zone to both legs of the structure.

This restoration did not require a custom truss product but, instead, required a highly specialized restoration installation procedure. An informed decision was made to use specialized equipment for the truss installation due to wetland location and the critical nature of these structures.
