**AN EVALUATION OF THE PERFORMANCE OF**  
**ZRC ZERO-VOC WATER-BASED**  
**COLD GALVANIZING COMPOUND**  
**AS WELDING REPAIR PER ASTM A 780 ON**  
**G90 HOT-DIP GALVANIZED STEEL**  
**IN 5% SALT SPRAY**

**Date: July 22, 2009**

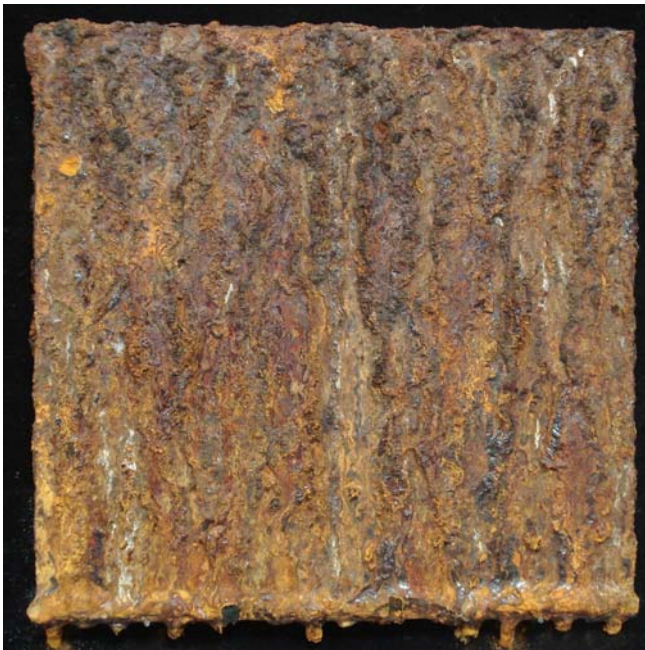
**Figure 1**

**Showing the control test piece after 4000 hours ASTM B 117 Salt Fog Testing.**

The results of this evaluation illustrate that ZRC Zero-VOC Water-Based Cold Galvanizing Compound affords outstanding protection against corrosion to welded and/or damaged areas of G90 hot-dip galvanized steel. Figure 2 shows the condition of the ZRC Zero-VOC Cold Galvanizing Compound coated test piece after 4000 hours of ASTM B117 Salt Fog Testing. Figure 1 shows the galvanized control test piece without ZRC Zero-VOC applied.

Figure 1 shows the condition of our control test piece, which received no surface preparation before testing. Over the course of 4000 hours salt fog testing, it has formed copious amounts of zinc salt on its surface as a result of the galvanic reaction caused when zinc sacrifices itself to protect the underlying substrate. However, it now exhibits a very significant amount of red rust across its surface, ASTM D 610 Rust Grade 0. The weld itself is totally corroded.

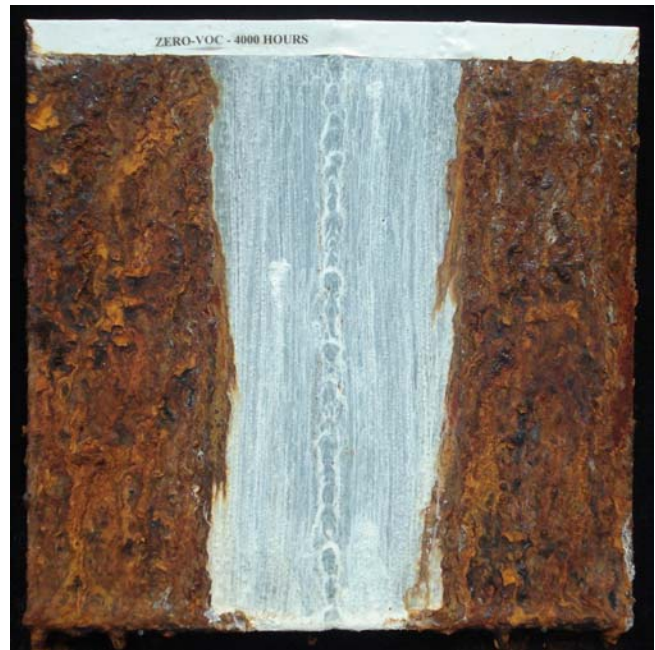
**Figure 2**

**Showing test piece with ZRC Zero-VOC applied after 4000 hours ASTM B 117 Salt Fog Testing.**

Figure 2 shows the condition of the ZRC Zero-VOC Water-Based Cold Galvanizing Compound coated test piece. On the uncoated area of the hot-dip galvanizing, similar to the control test piece, this panel has also formed copious amounts of zinc salt, followed by very significant amounts of red rust, ASTM D 610 Rust Grade 0.

However, where ZRC Zero-VOC has been applied to the weld and surrounding area, there is no rust, only light formation of zinc hydroxycarbonate salt, typical of bonafide zinc rich coatings. No blistering was observed on the weld and the surrounding coated area. Extremely light blistering was observed at the interface between ZRC Zero-VOC and the uncoated hot-dip galvanizing, ASTM D 714 6-M, seemingly caused by the formation of the copious amounts of zinc salt on the uncoated area bleeding over.

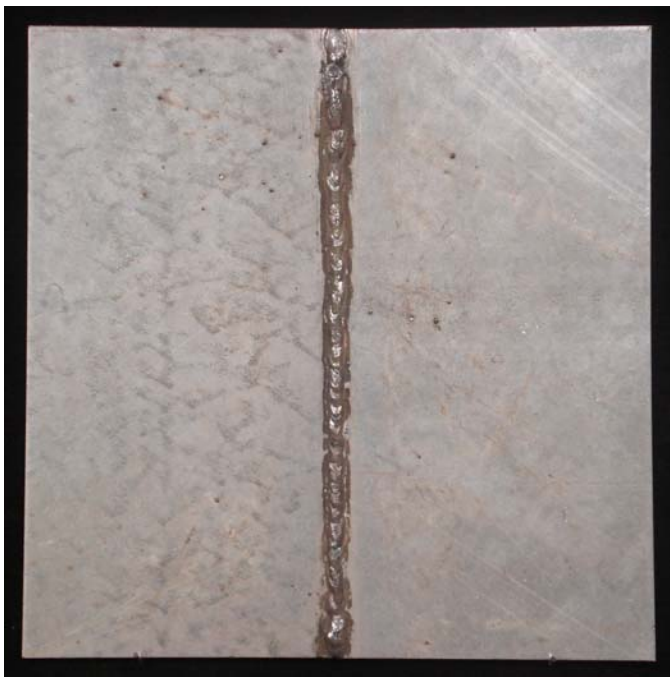
**Figure 3**  
**Showing a representative**  
**test piece after MIG welding.**

In this experiment, 11 gauge panels of G90 specified hot-dip galvanized steel (ASTM A 526) were obtained from Ledford Steel Company, Winchester, KY and employed as the substrate. Two panels of the substrate were MIG-welded together to create the test area. Figure 3 shows the test piece after welding. The welded area was then Power Tool Cleaned (SSPC-SP 11). The surrounding area was Hand Tool Cleaned (SSPC-SP 2). The surface of the whole test piece was then Solvent Cleaned (SSPC-SP 1) using MEK. Figure 4 illustrates the test piece after cleaning.

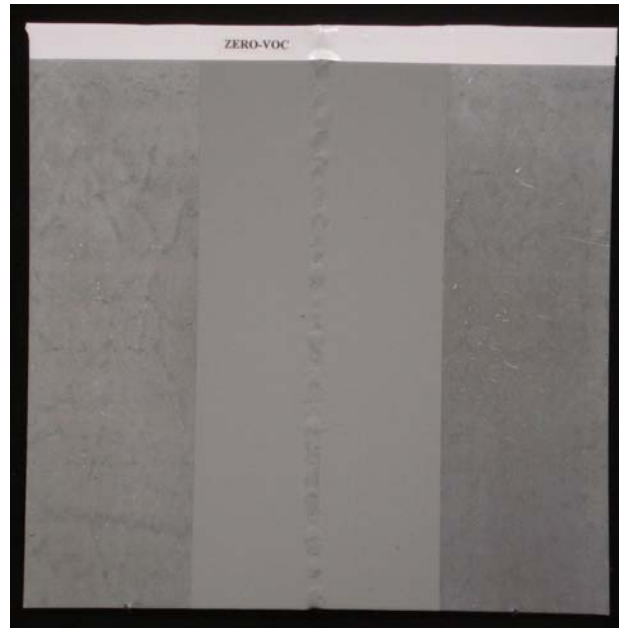
**Figure 5**  
**Showing test piece after application of ZRC Zero-VOC.**

Two coats of ZRC Zero-VOC were applied from randomly chosen cans (after blending and straining) by brush to a total dry film thickness of 2.8 mils (recorded with a Positector 6000 series magnetic film thickness gauge, per SSPC-PA 2), allowing a 24-hour dry time at 25°C between coats. ZRC Zero-VOC was overlapped 1.5 inches over the galvanized surface on either side of the weld. Figure 5 shows the panel after ZRC Zero-VOC application.

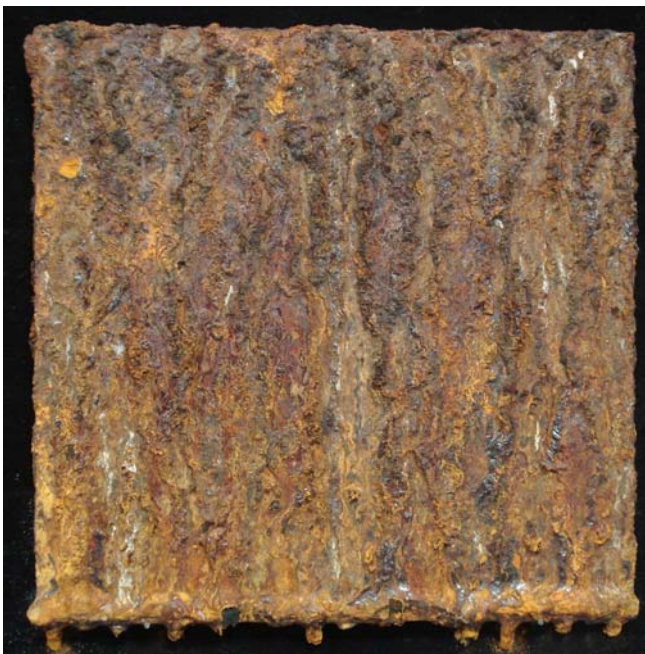
**Figure 1**

**Showing the control test piece after 4000 hours ASTM B 117 Salt Fog Testing.**

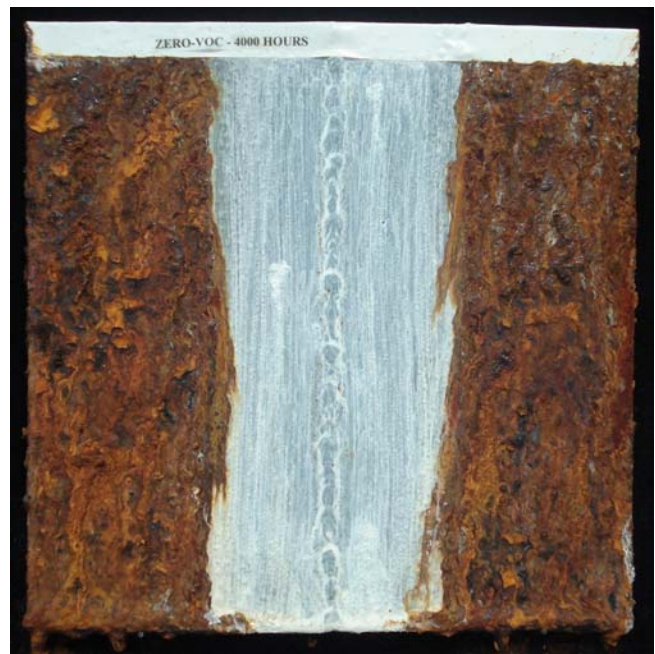
**Figure 2**

**Showing test piece with ZRC Zero-VOC applied after 4000 hours ASTM B 117 Salt Fog Testing.**
